Oblast	Choma
Lokalita	Masopo
GPS koordináty	J 16,83261 V 27,10423 m.n.m. 1276
Činnost	4.3.1, 4.3.2
Popis technických prací	geofyzikální průzkum; realizace hydrogeologického průzkumného vrtu, konečný průměr vrtu 8", výstroj vrtu, obsyp a těsnění, zhlaví; hydrodynamická zkouška (čerpací 72h , stoupací 24h); dodávka a montáž technologie pro jímání podzemní vody (čerpadlo na solární energii, solární panely, měřicí a regulační technika, zásobník o objemu 20m ³) výtlačné a distribuční potrubí, odběrné místo, napájecí žlab.
Popis lokality	v širším okolí jsou v současnosti využívány mělké studny i vrty; lokalita je dostupná pro těžkou vrtnou techniku.
Související dokumentace	Masopo Design.dwg Masopo Report.pdf
Fotodokumentace

MASOPO WATER SOURCES FOR FARM ANIMALS

CHOMA MUTANDALIKE WATER SOURCES FOR FARM ANIMALS

Surveyed by: J. Ngambi	Title: Proposed Rehabilitations of Sigubu dam
Drawn by: J. Ngambi	District: Monze
Approved by: M. Sinfukwe	Date: February, 2017.
Designed by: J. Ngambi	Ownership: Community

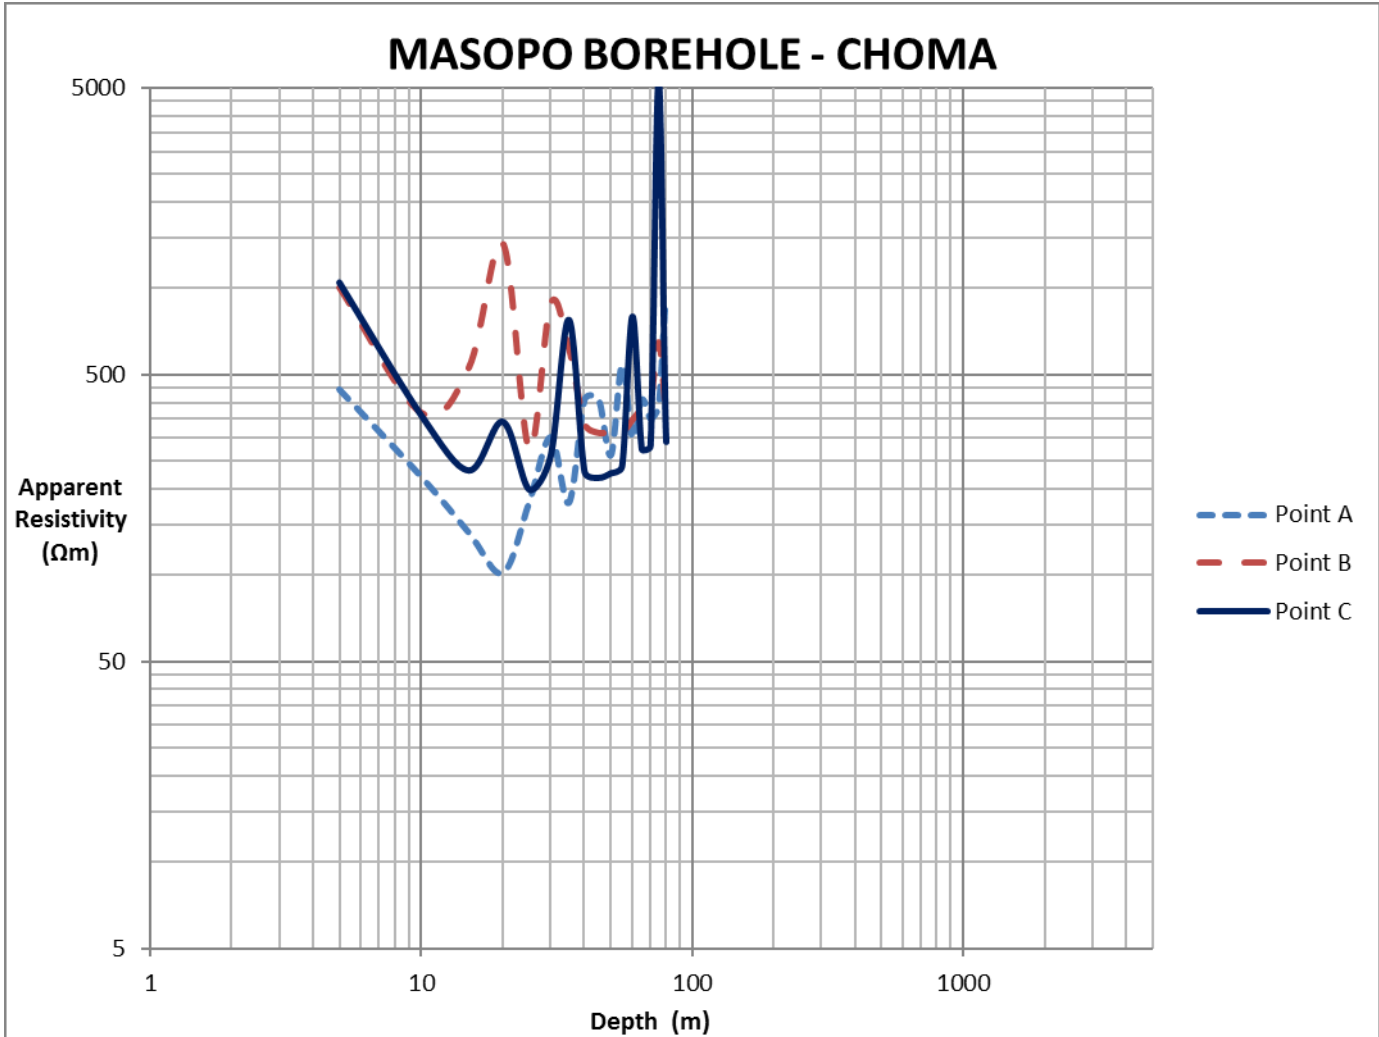
4.1.2 GEOPHYSICAL SURVEY GRAPH

The general geological formation for the area as shown from the graph is sandstone ranging from loose to consolidated sandstone. If drilling is the preferred intervention, the recommended site is point number C drilled up to 80m. According to the results water is expected to be struck at 15m -30m, 40m – 55m and 65m – 70m respectively. The expected yield cannot be ascertained now due to other factors but the assumption can be gotten from the hydrogeological zone that the area falls in which is low yield (0 – 2L/sec.)

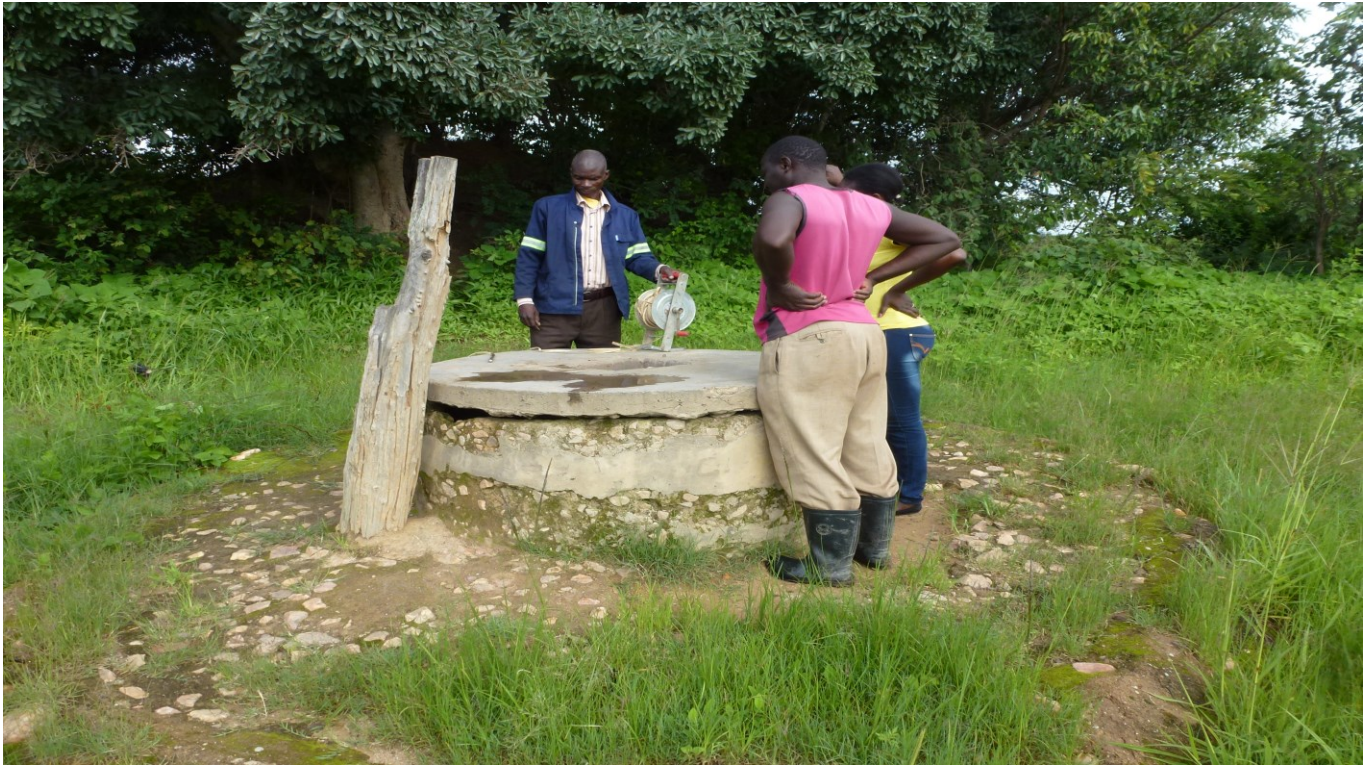
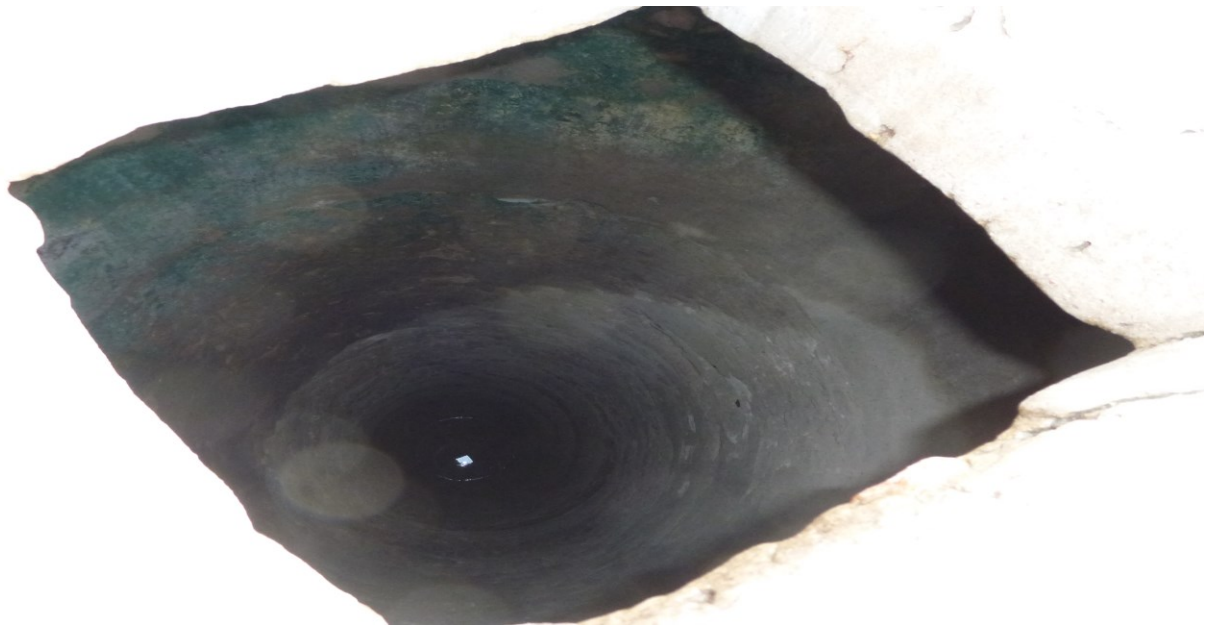
Pictures 1 & 2: Siamungala Well: GPS S16° 50' 14.52999", E027° 6' 13,300"

There are three Hand dug well in the area as shown above namely Nzumba, Alex and Siamungala which had water at the time of the survey. According to the community the water last only up August/September of each and every year, and the water quality is not good according to the community.

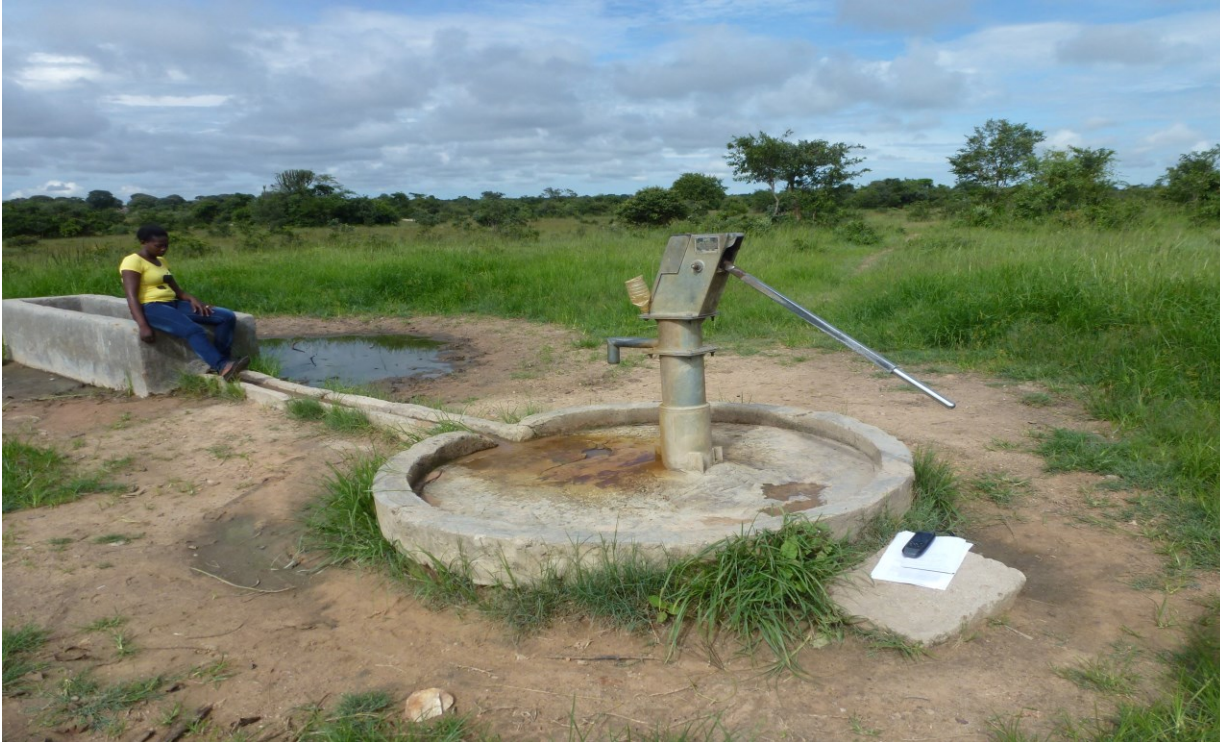
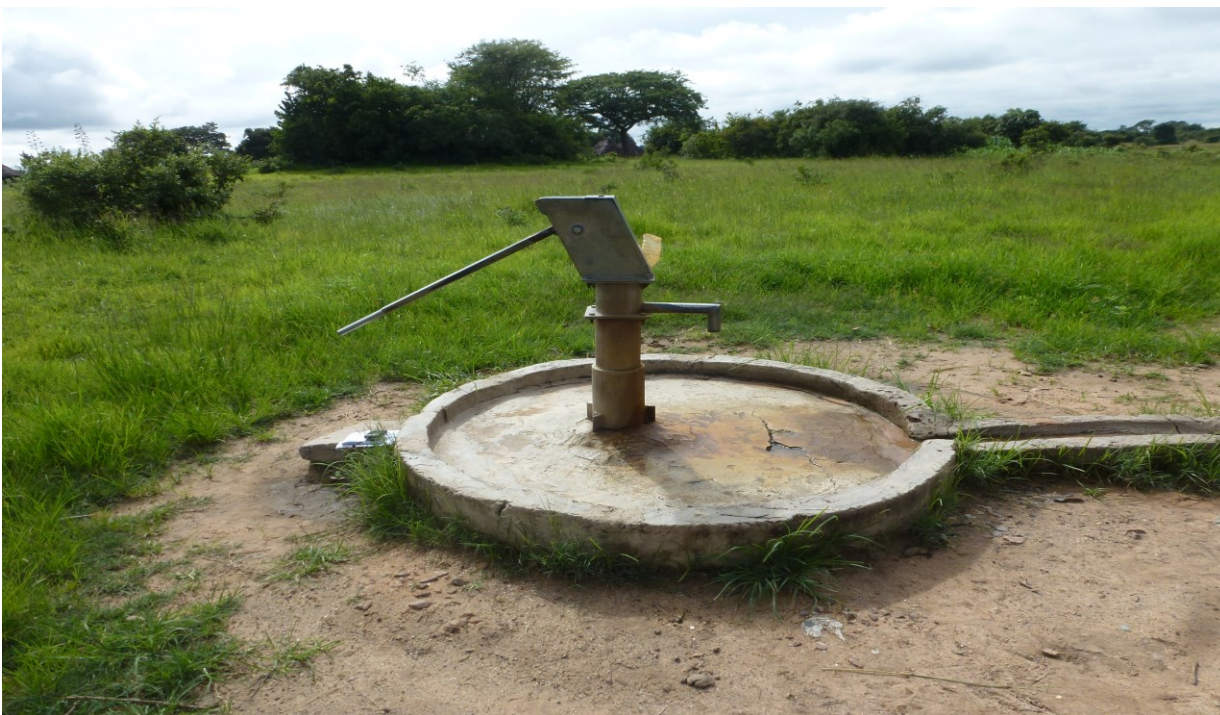
Pictures 1 & 2: Nzumba Borehole: GPS S16° 50' 6.6399", E027° 7' 7.2200"

There are two drilled borehole which are installed with India Mark II handpump about 4km from the site as shown above namely Nzumba and Sikalongo Settlement which were operation at the time of the survey. According to the community the water never finishes during the year, and the water quality is good.

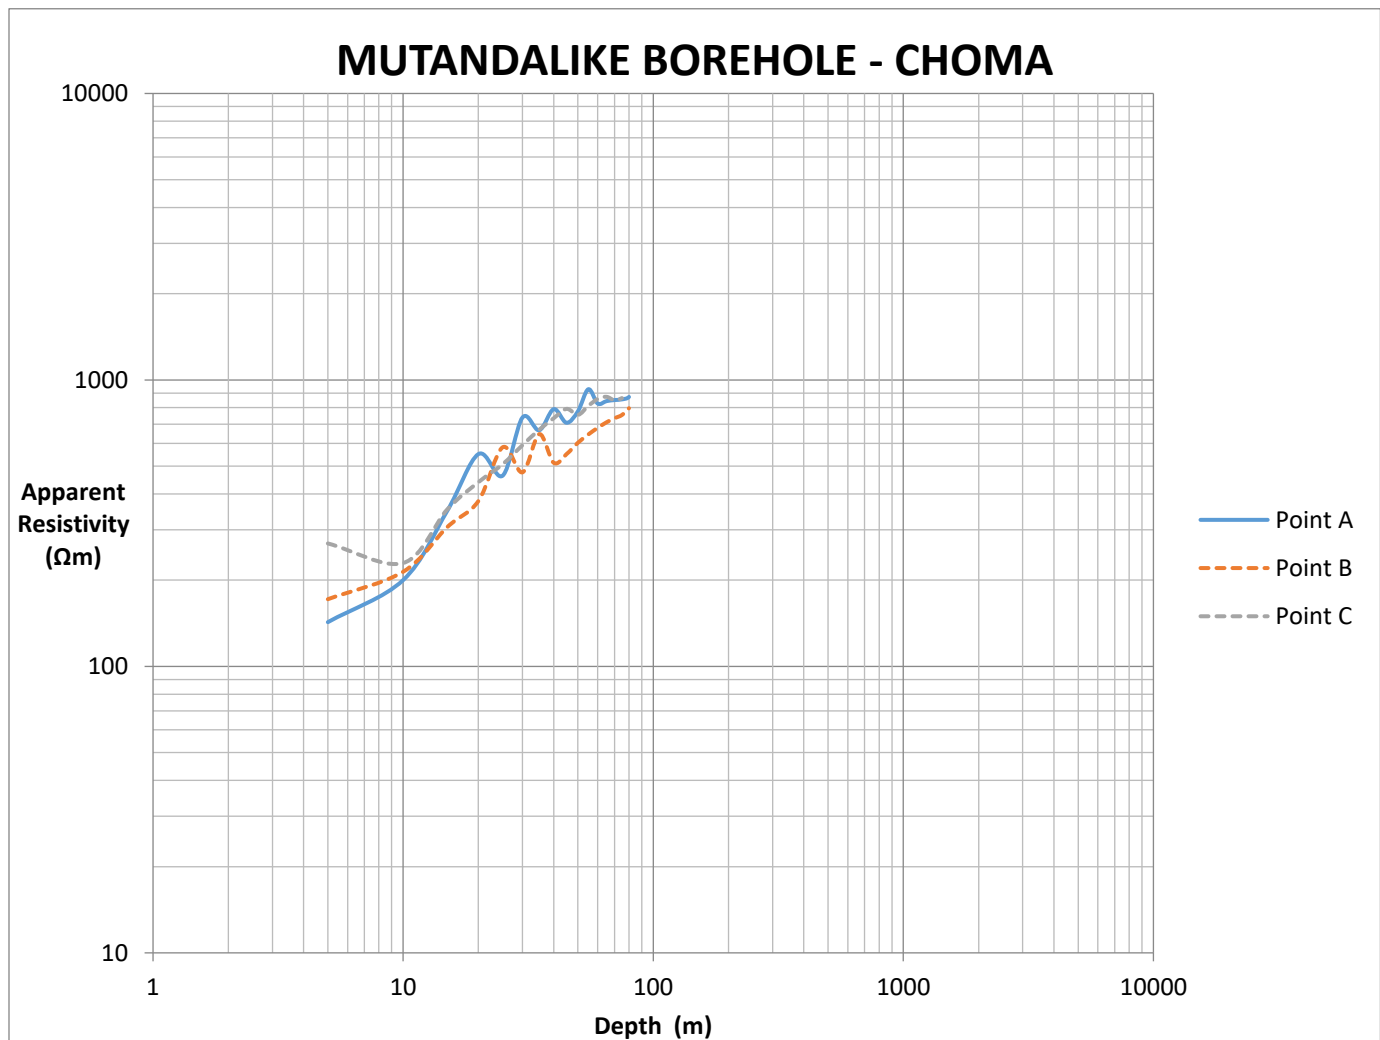
5.2.2 GEOPHYSICAL SURVEY GRAPH

The general geological formation for the area as shown from the graph is basaltic ranging from weathered to consolidated. If drilling is the preferred intervention, the recommended site is point number B drilled up to 60m. According to the results water is expected to be struck at 25m – 55m respectively. The expected yield cannot be ascertained now due to other factors but the assumption can be gotten from the hydrogeological zone that the area falls in which is low yield (0 – 2L/sec).

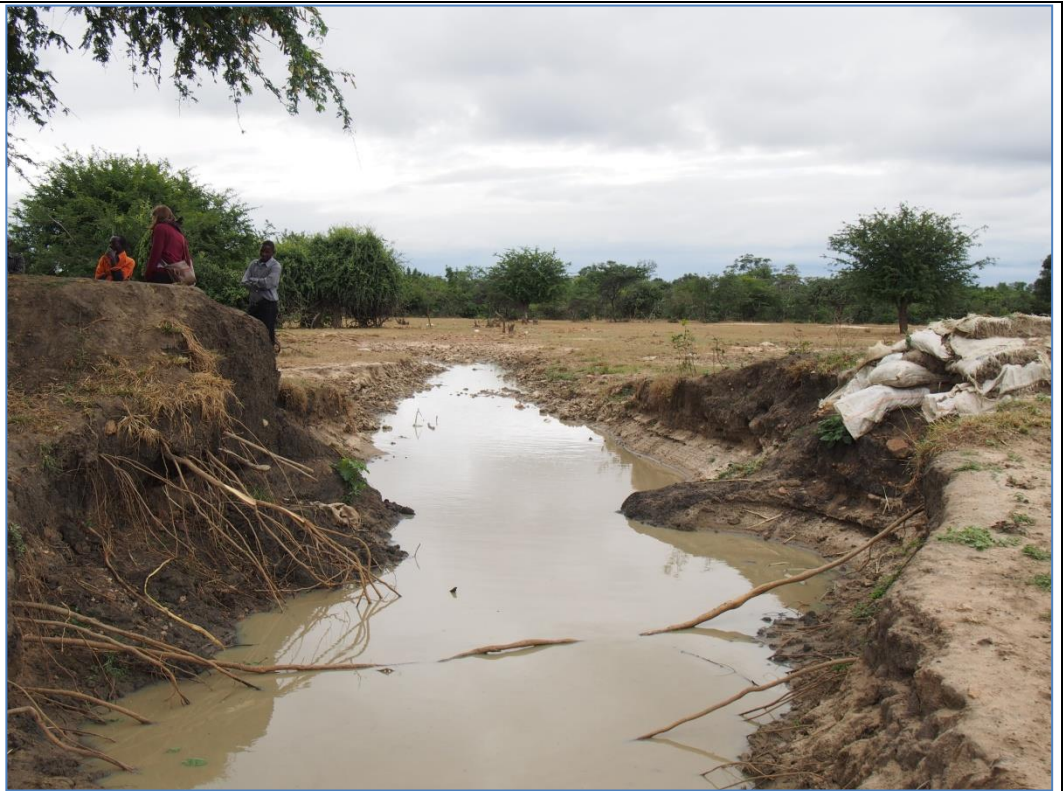
Protržená část hráze

- NOTES:
- The repairs to be done at the time of the water level is at it's lowest and allowing more time before rainy season.
 - All loose and poor soils must be removed from the surface of the embankment - Suitable soil material must be placed and compacted in layers of 150mm to repair the breached portion.
 - The upstream should be sliced to a reasonable slope and thereby reducing the crest width to 2 metres.
 - The crest level should be raised (built) to 100.2 metres.
 - Ant-workings found, must be suitably treated with a recommended fumigant, dug-out and the excavations backfilled in layers with good soils. All shapes must be retored to the reasonable design shape.
 - A toe-drain must be constructed on the downstream.
