Plant number 070-7310 line 4
Atomizers type F-100EMC s/n 2240 and 2241

**Subject: Report of the first maintenance of atomizer F-100 EMC
s/n 2240 and s/n 2241.**

18.10.2020

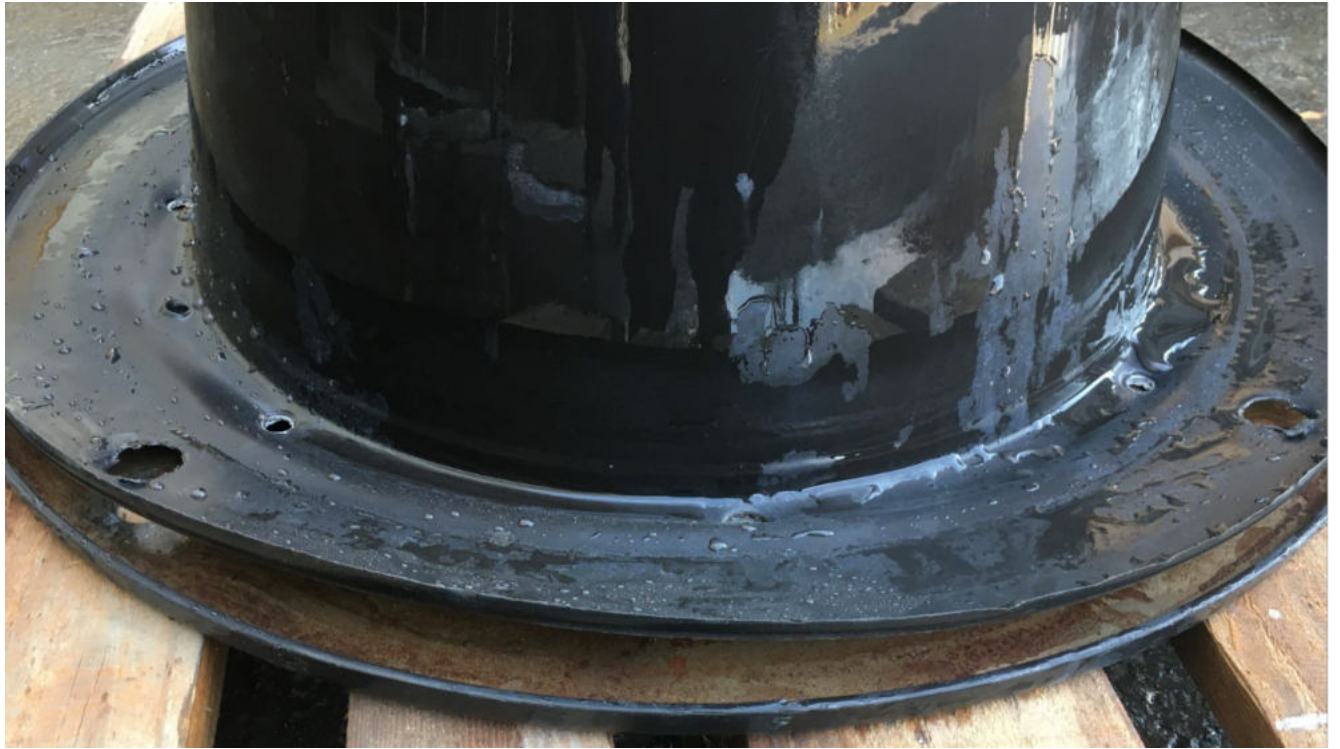
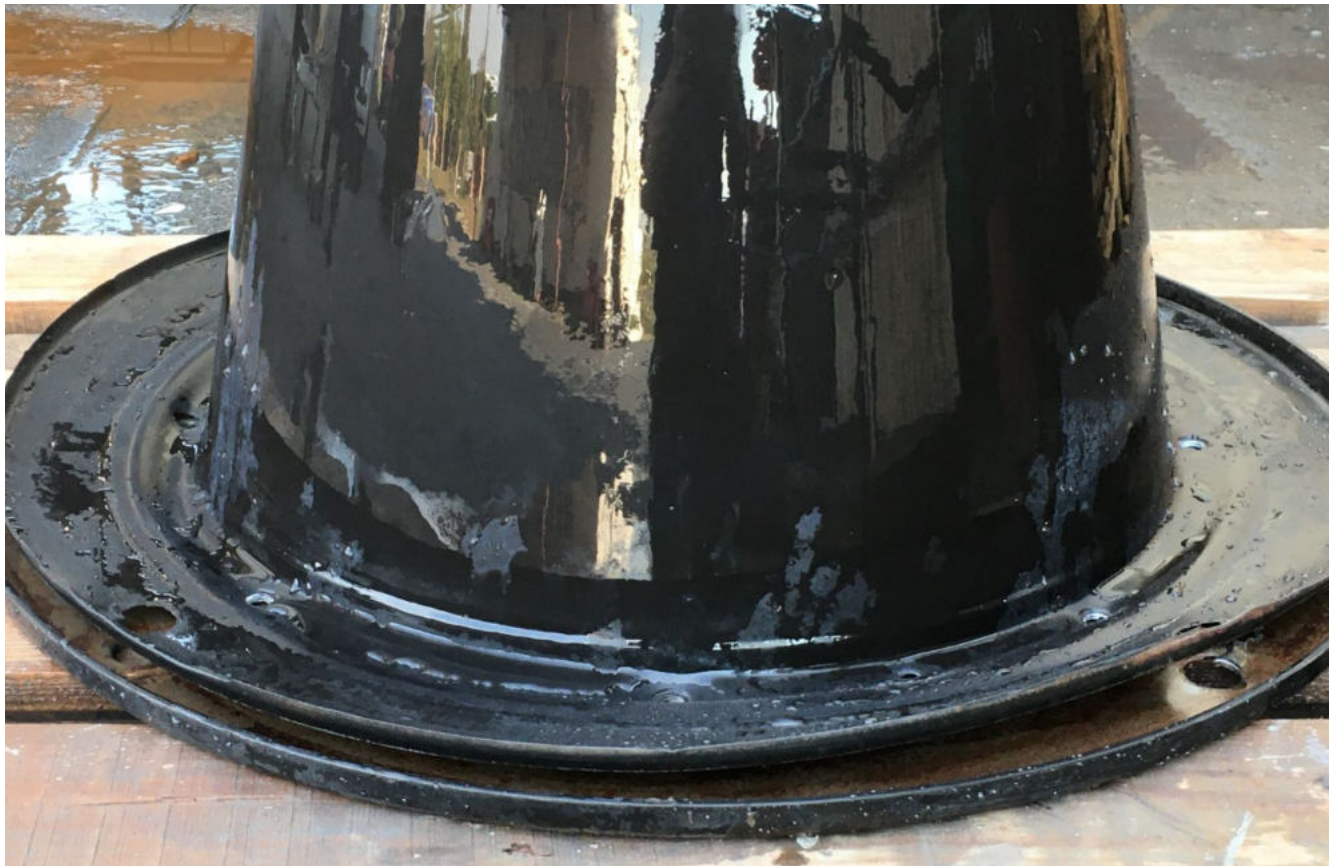
At this skirt the coating was loosen below the flange, this is for the operation without any risk or problem but must be repaired or change out. GEA Process Engineering A/S is already informed about this issue.

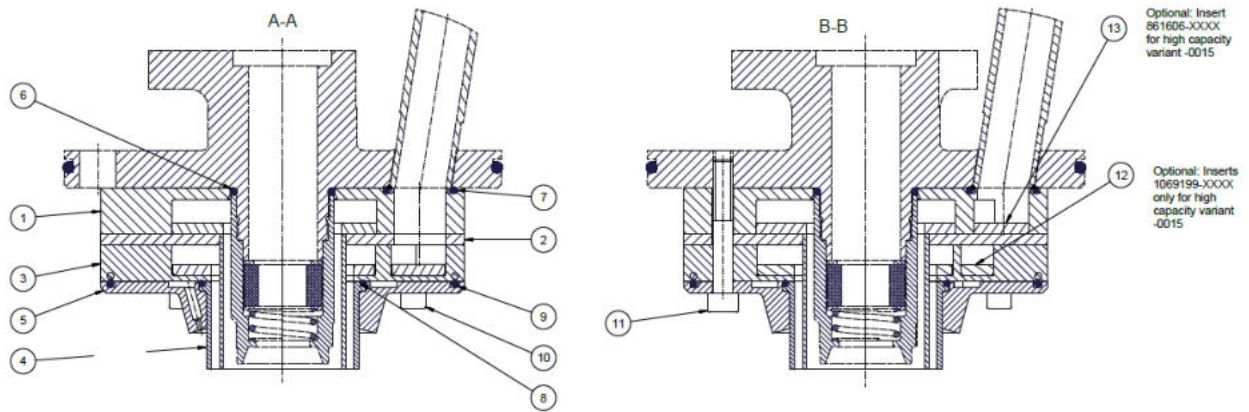
This atomizer has a twin volute liquid distributor 761492-0017, means an upper (inner) volute 761494-0418 what is not in use and for the wastewater a lower (outer) volute 671977-0416 with 2 pc inserts 1069199-2004 (2 x 4 mm)

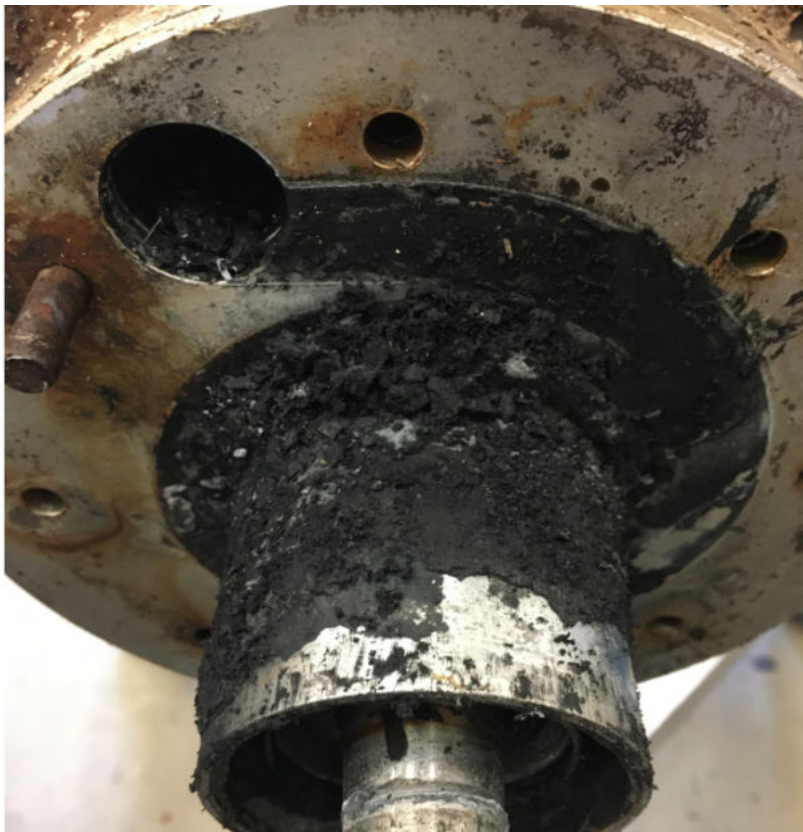
After dismantling the volute distributor, it was showed that both volutes were used and both feed pipes showed a rest product from the wastewater.

See pictures below: This is the lower (outer) Volute what is the correct one. Seen from the front of the atomizer the feed pipe on the left side.

The spring 010136-0001 was nearly cone and this gives the guide bearing 010612-0001 no load anymore. After contact Denmark we will use only a spring 010136-0002 (Monel) and washer 10132/010134-0003 from Hastelloy.

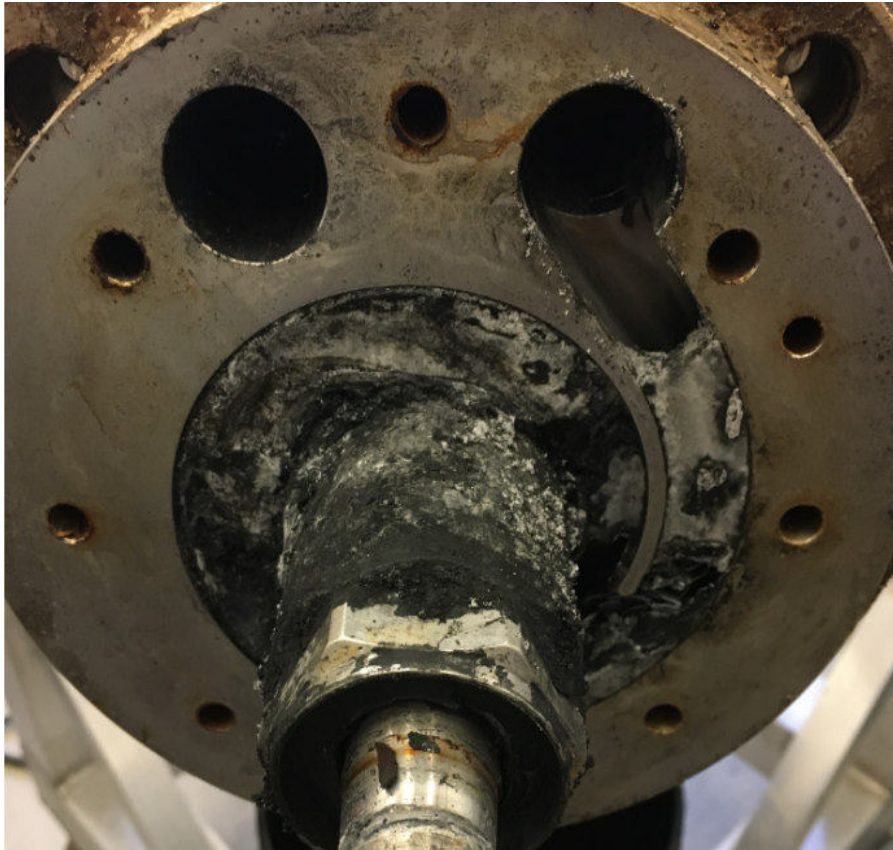
The below picture shows the upper (inner) Volute, what should be complete clean because this feed line was blocked at the start up.

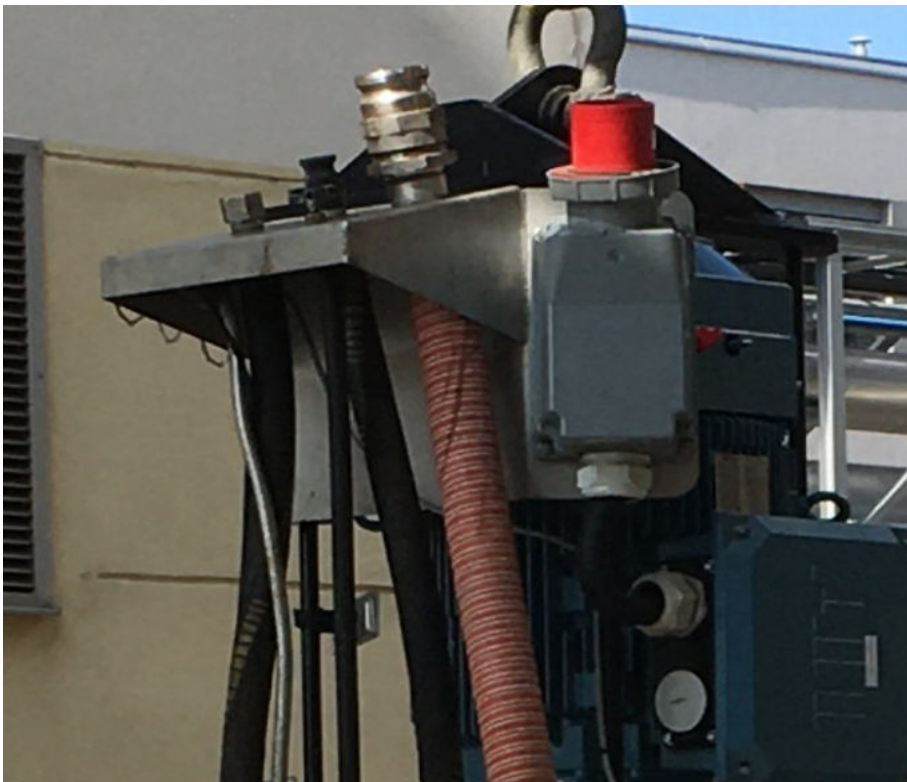
The next step was to check the feed inlet on the extension part of the main motor, here we see that someone changed the inlet from the left (lower volute) to the right side (upper volute)

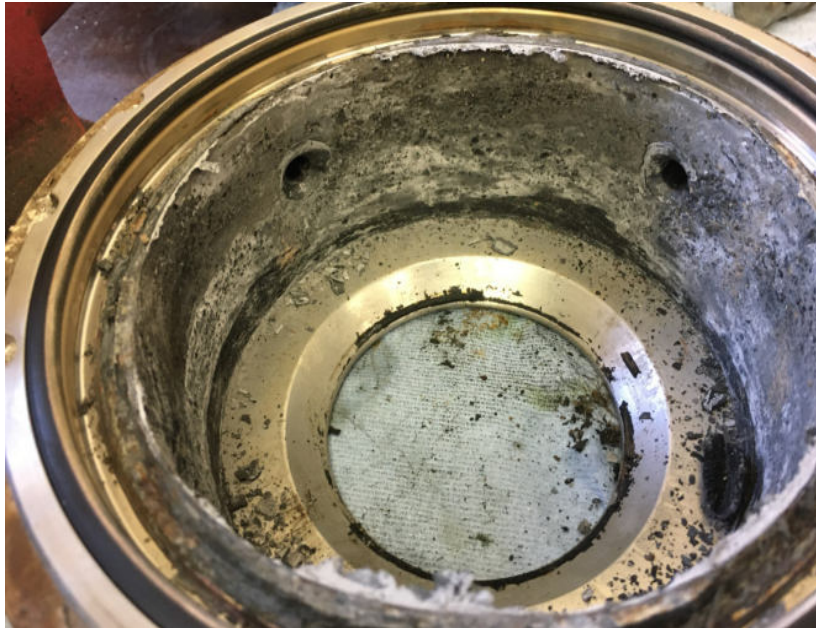
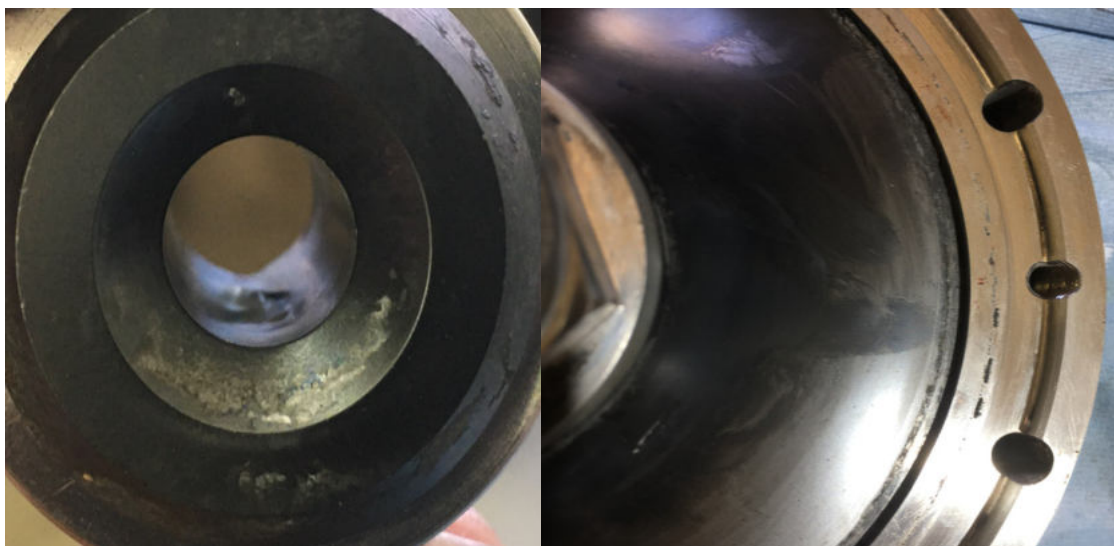
The atomizer wheel is complete opened and showed low wear.in the inserts. A nice layer of product was seen in the wheel.

Only the ring around the bottom wear plate 063507-0002 showed some marks.

The complete wheel is cleaned and build together with new O-rings. The inserts are turned 180°

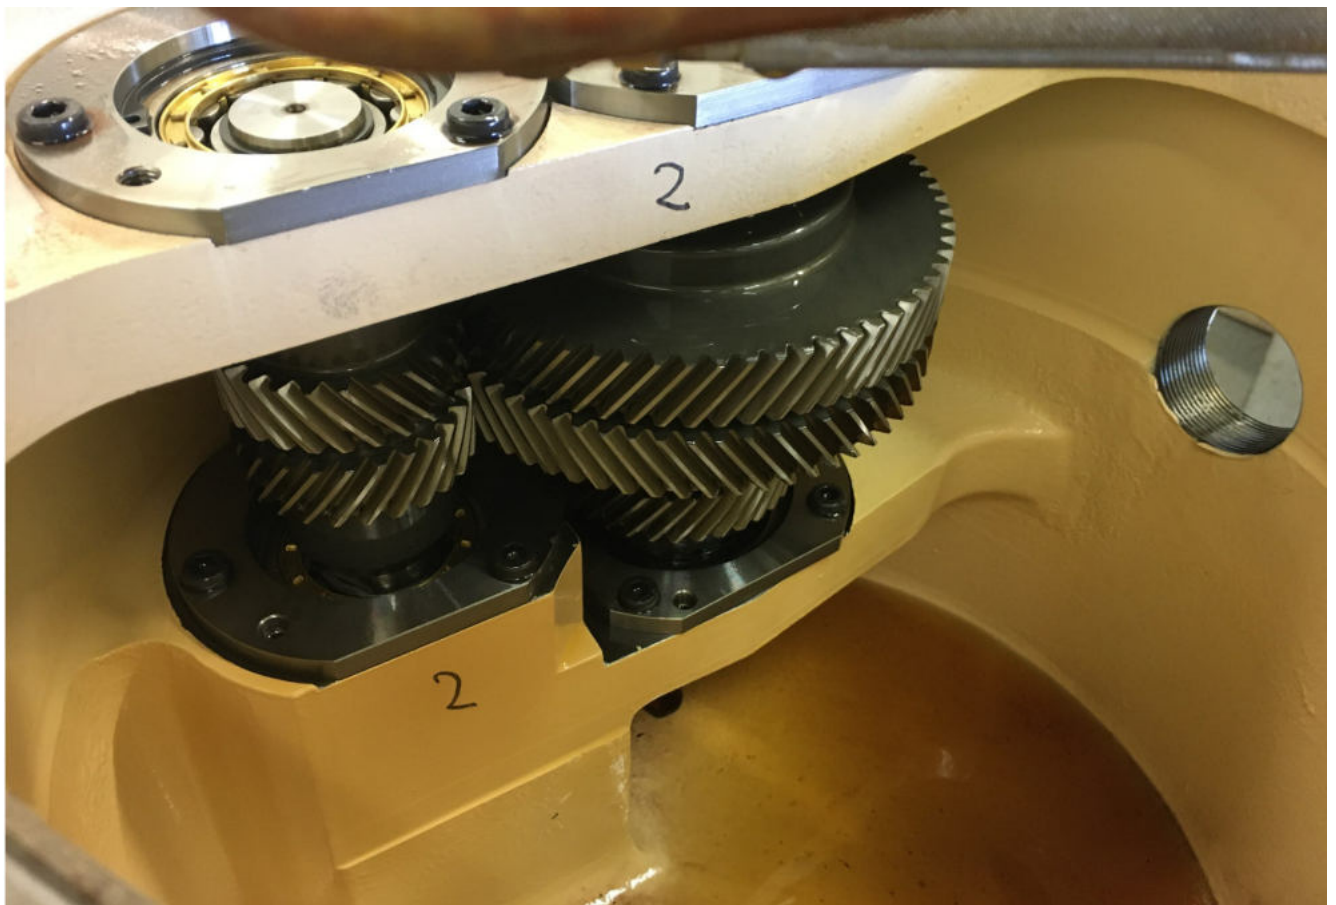
All looked very good, the gearbox was clean, no burned oil. See picture below:

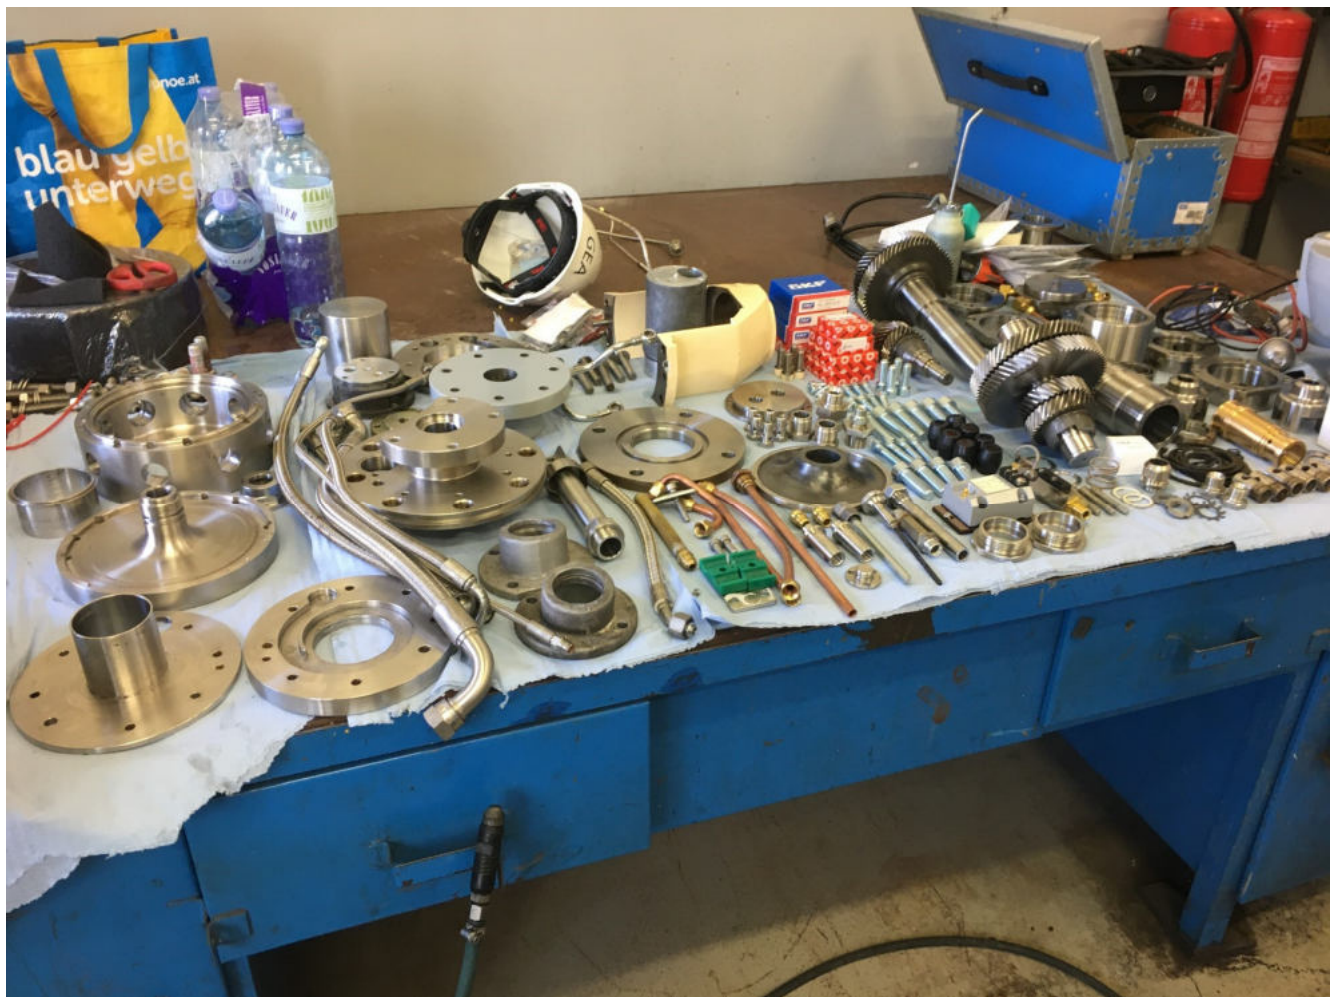
Below a picture of most of the cleaned parts before assembling:

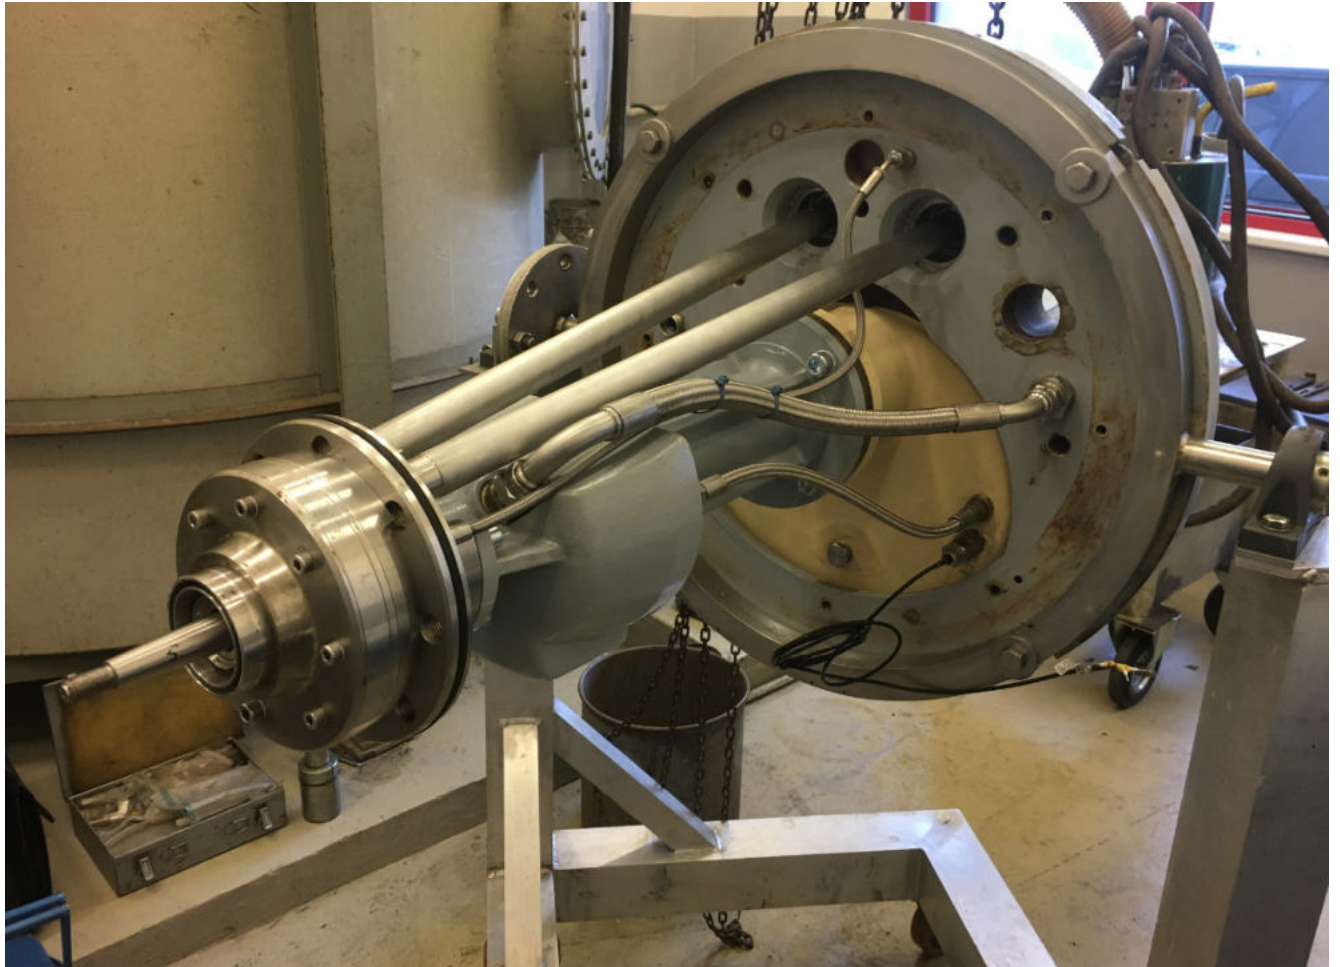
The complete atomizer was built up with new gaskets and O-Rings.
See below the lower part of the atomizer after assembling:

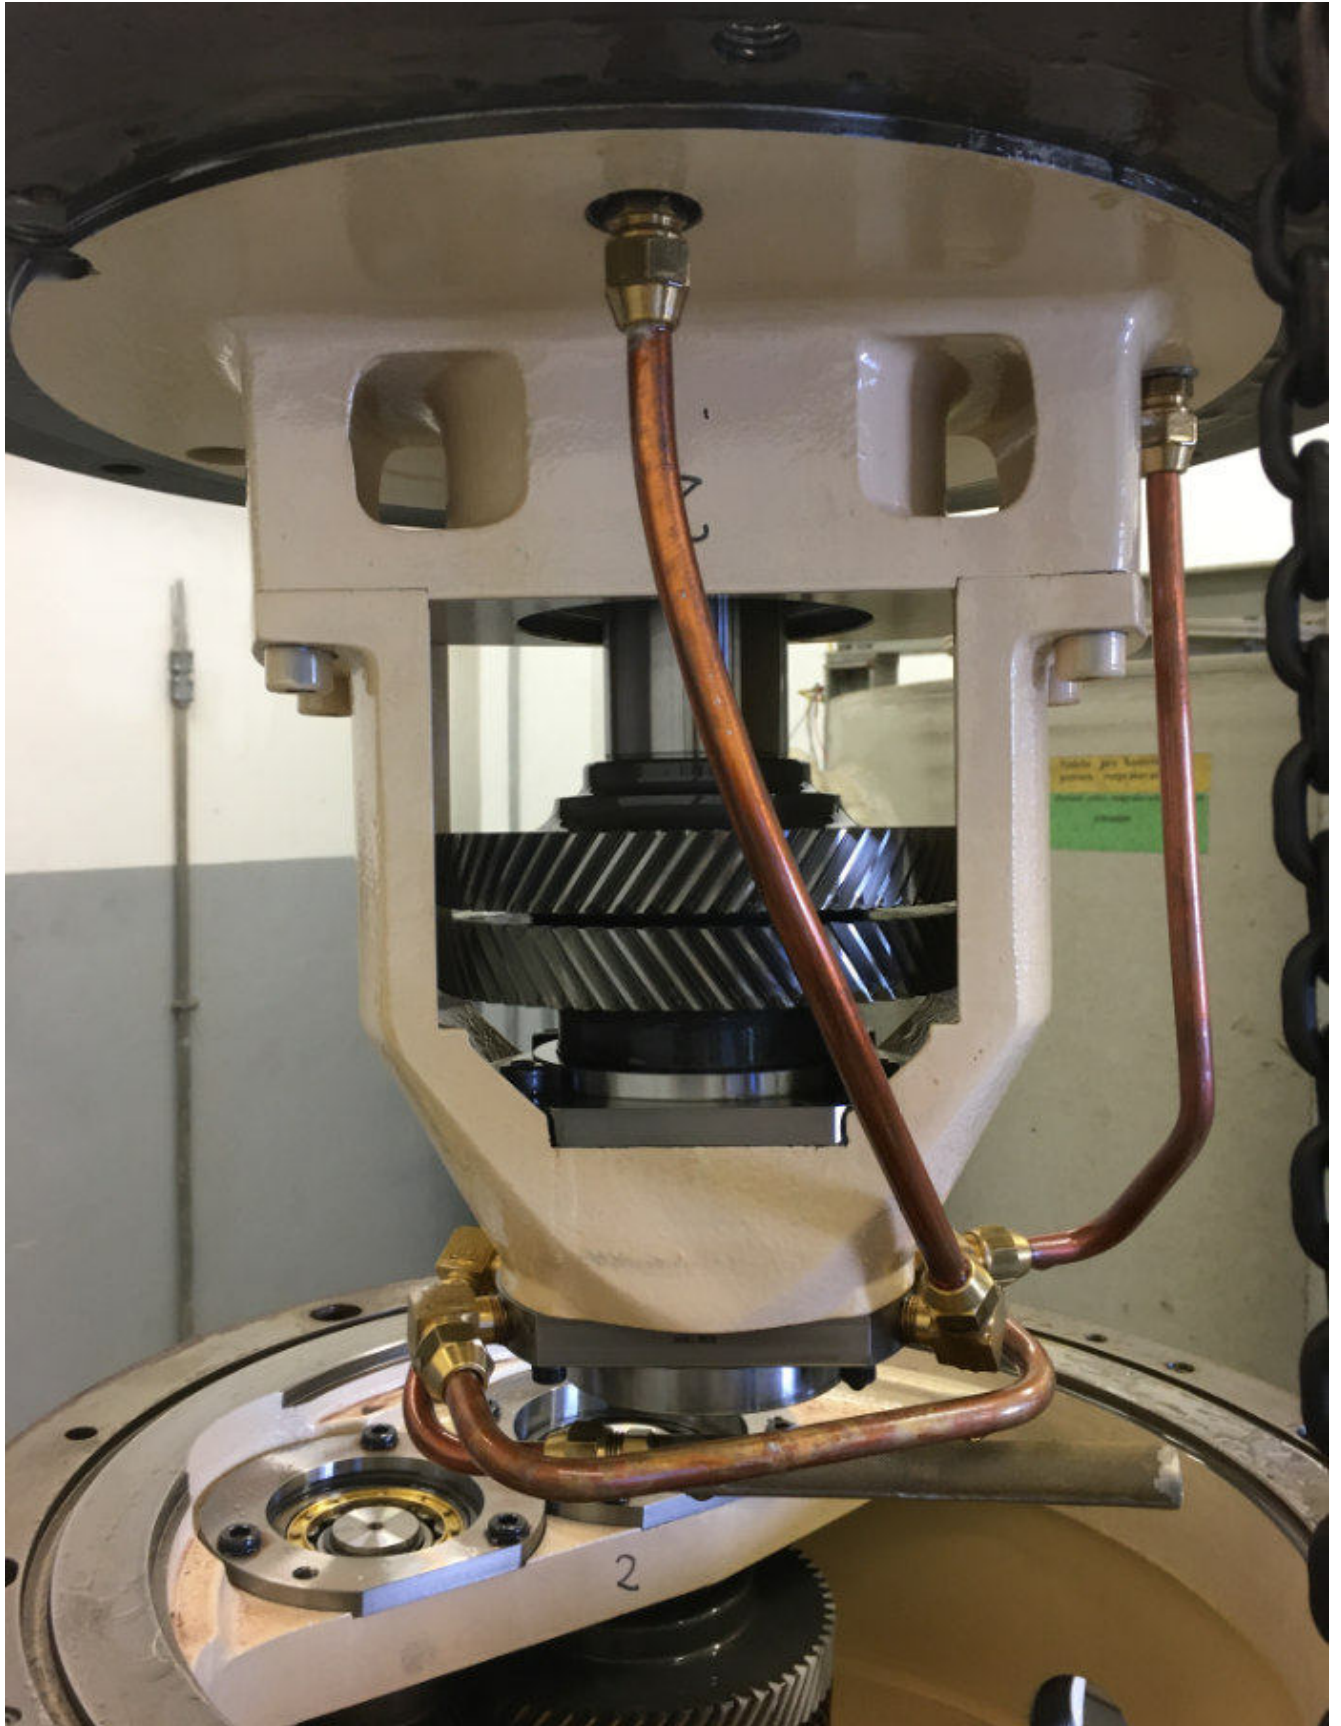
The complete gear is mounted into the gearbox; new coupling inserts 010113-0001 are placed.
See picture below:

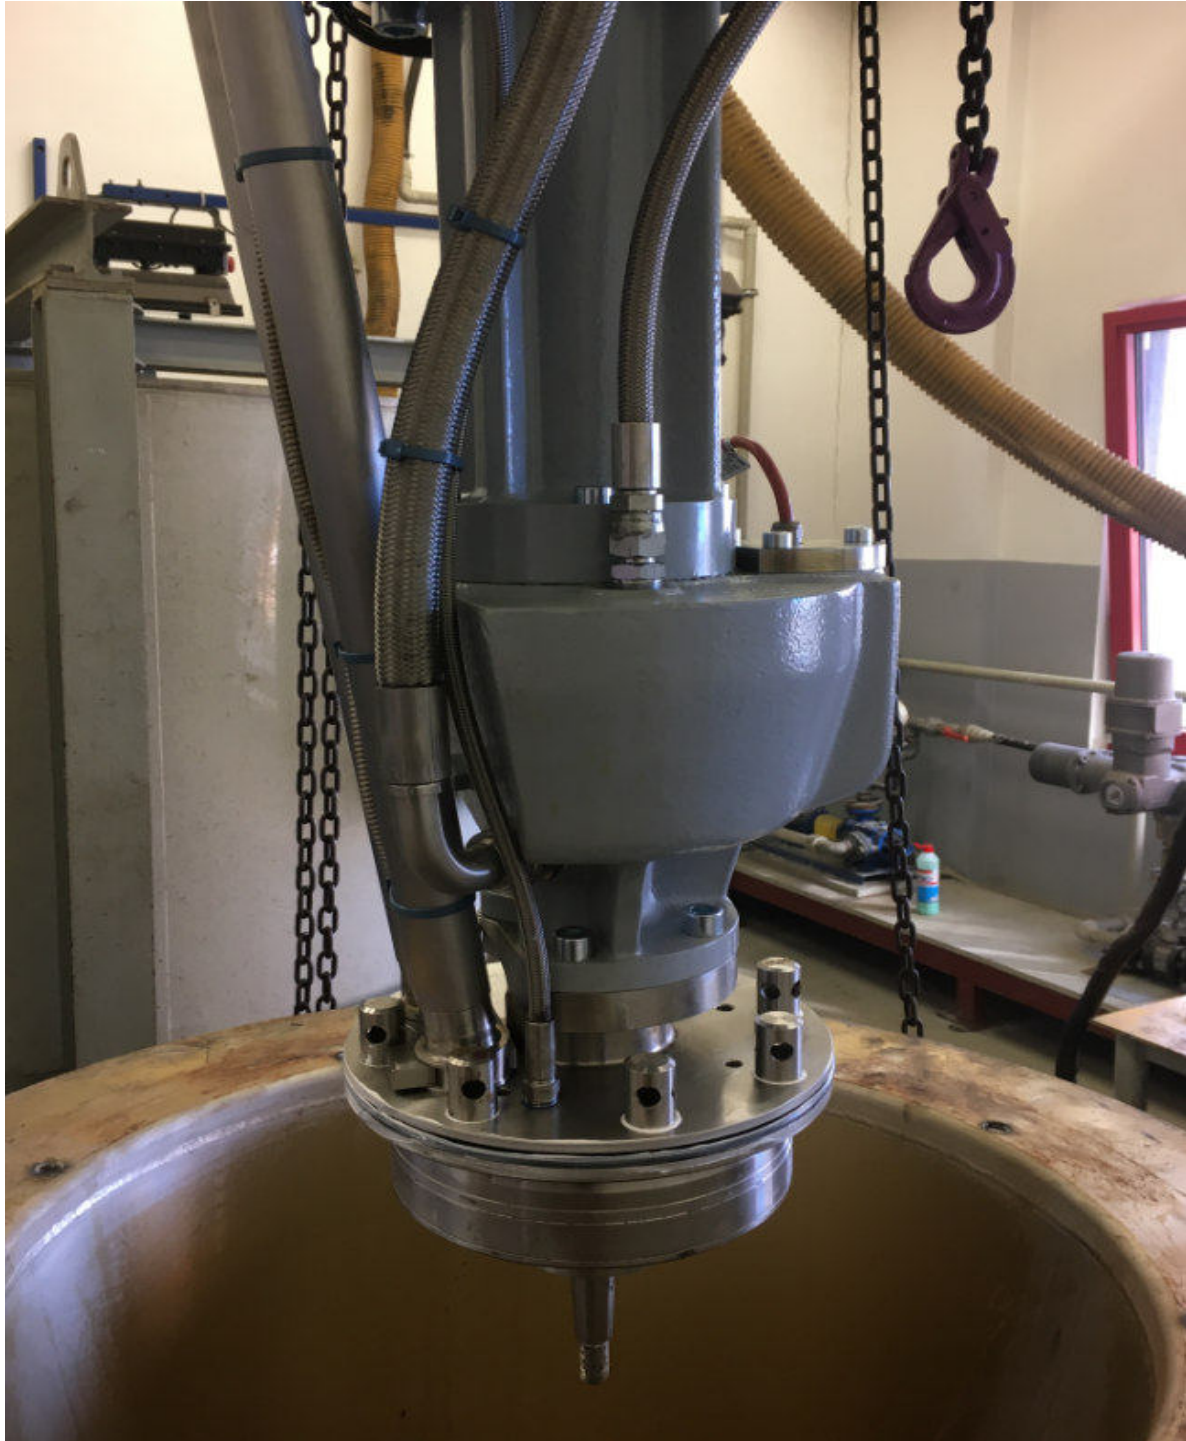
Below a picture of the atomizer before mounting the skirt:

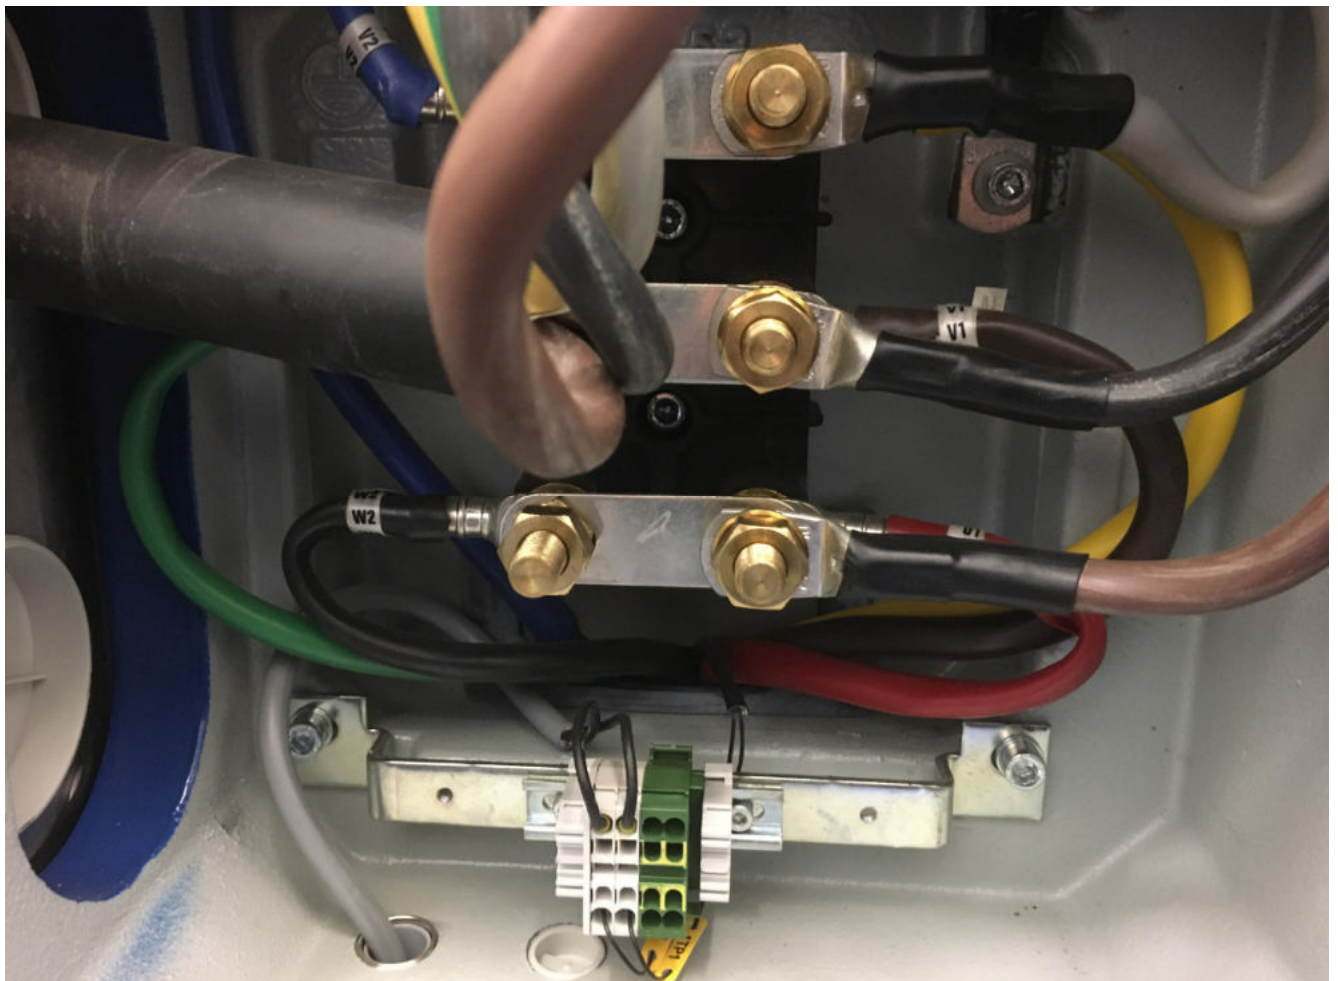
First was to dismount the main electrical connector and wires, see picture below:

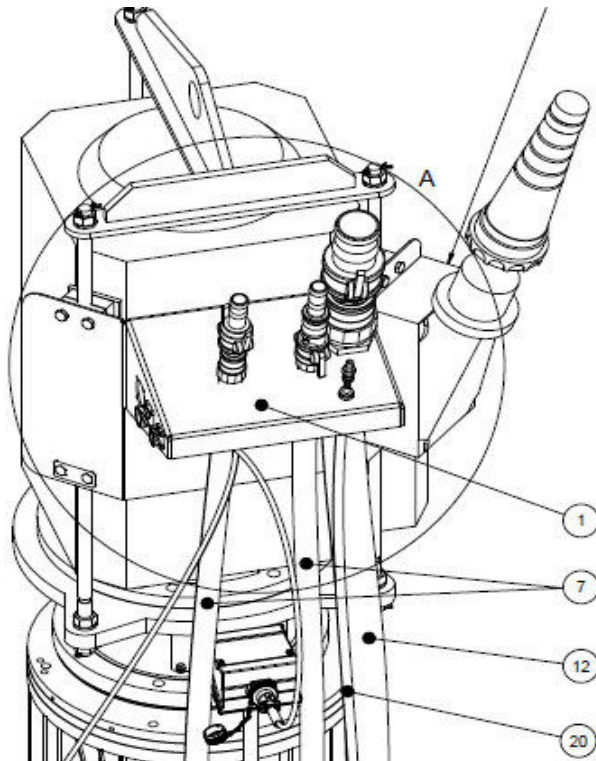
Next step was to dismantle the lifting device, stay bolts and extension complete.

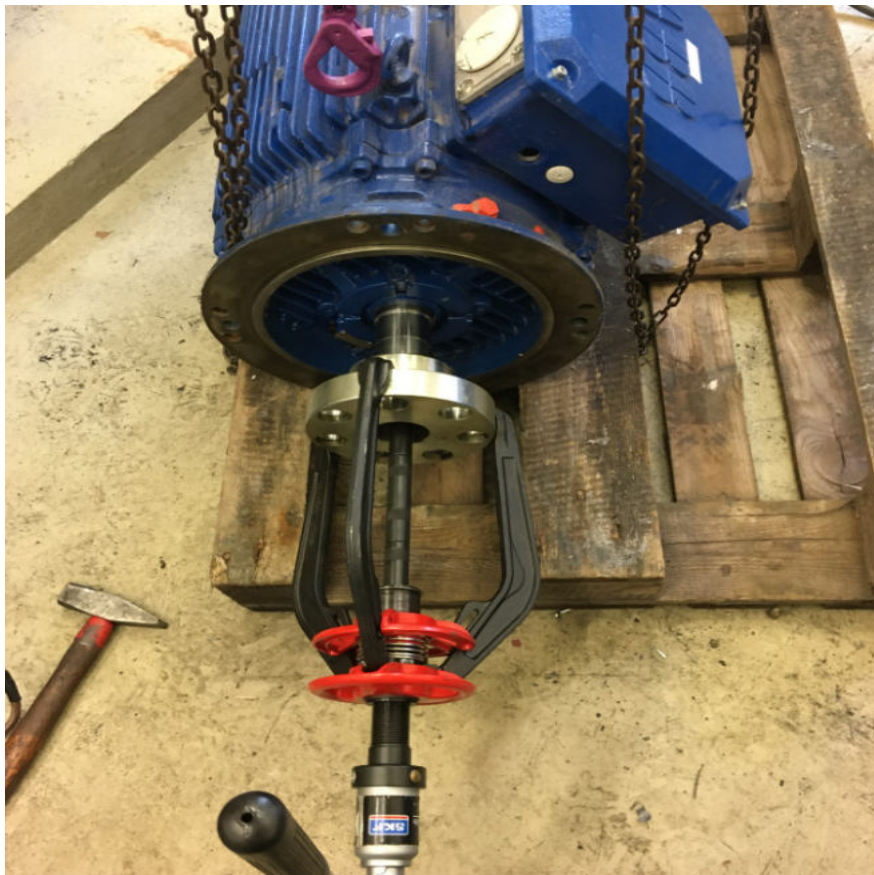
Also, the motor coupling must take off:

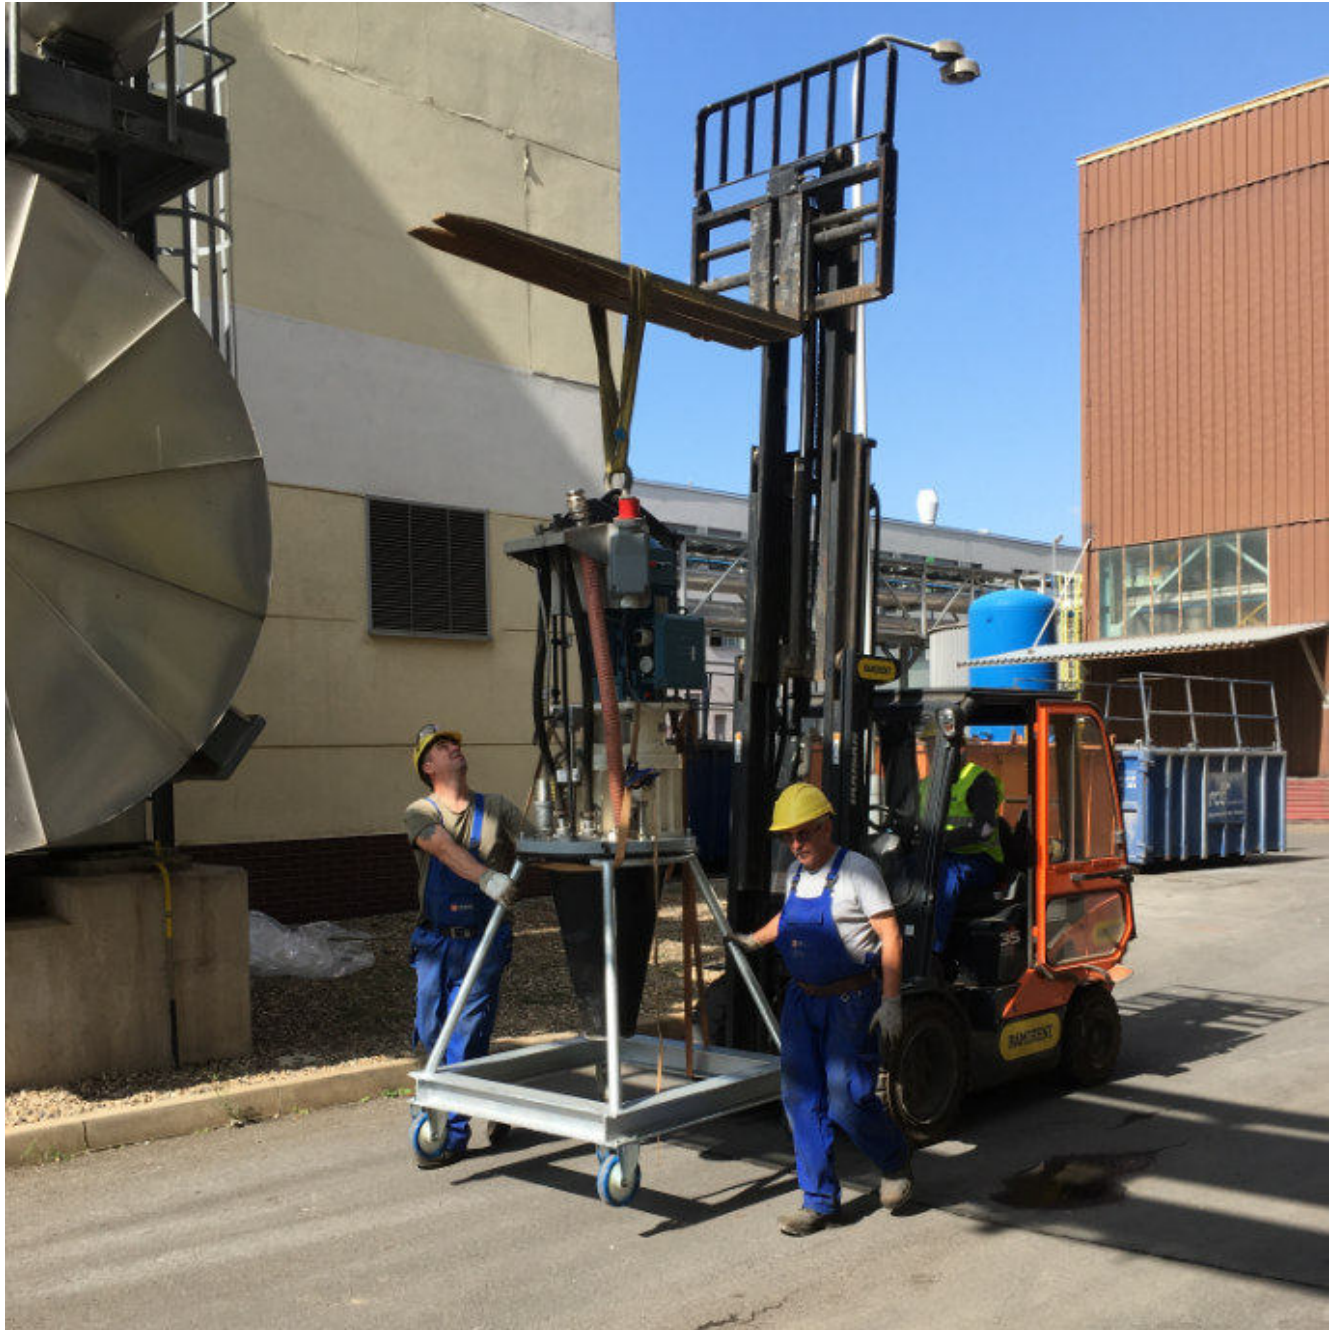
The atomizer and motor were connected by forklift outside of the building and the complete unit was transported to the crane:
