Plant number 070-7310 line 4
Atomizers type F-100EMC s/n 2240 and 2241

**Subject: Report of the first maintenance of atomizer F-100 EMC
s/n 2240 and s/n 2241.**

18.10.2020

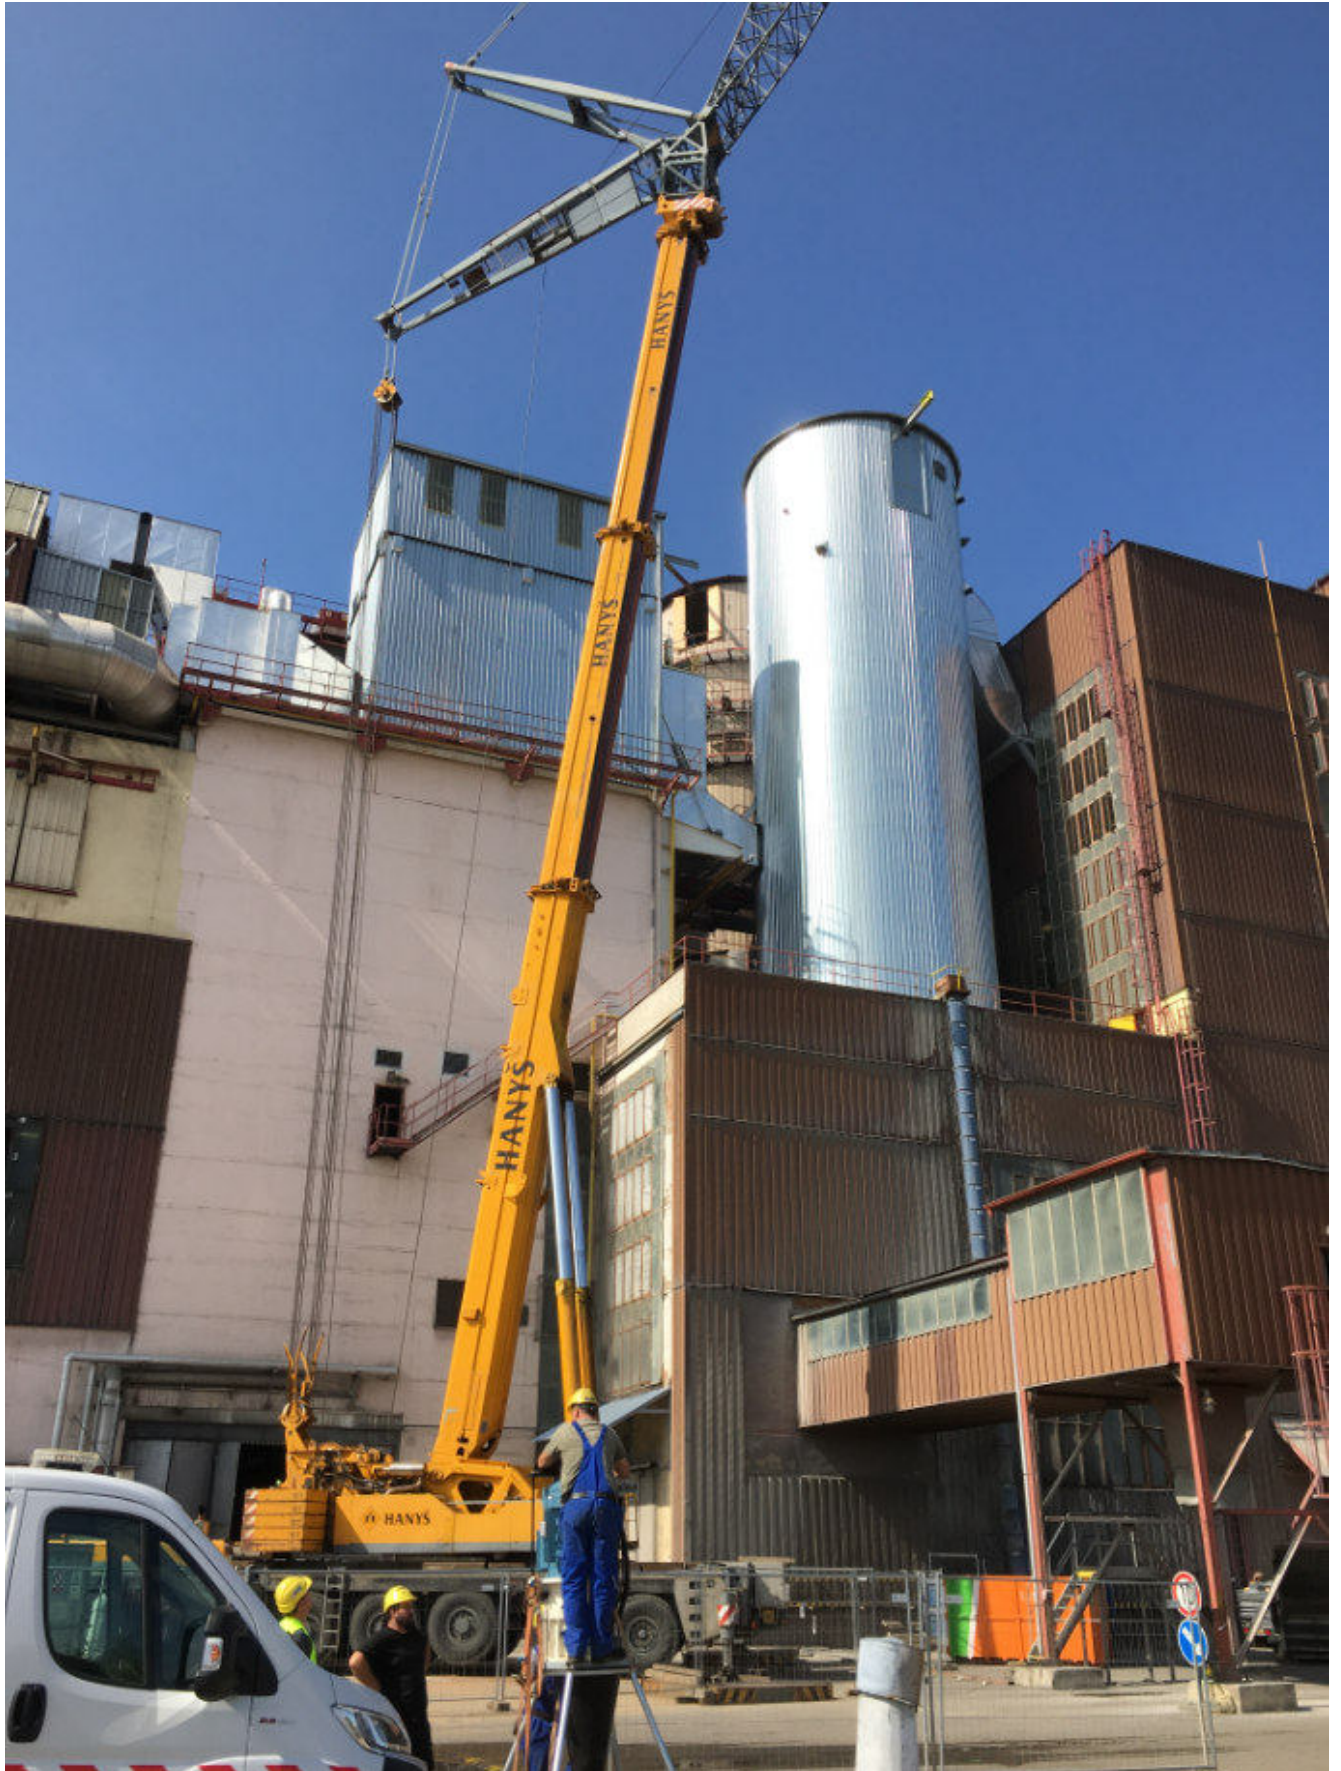
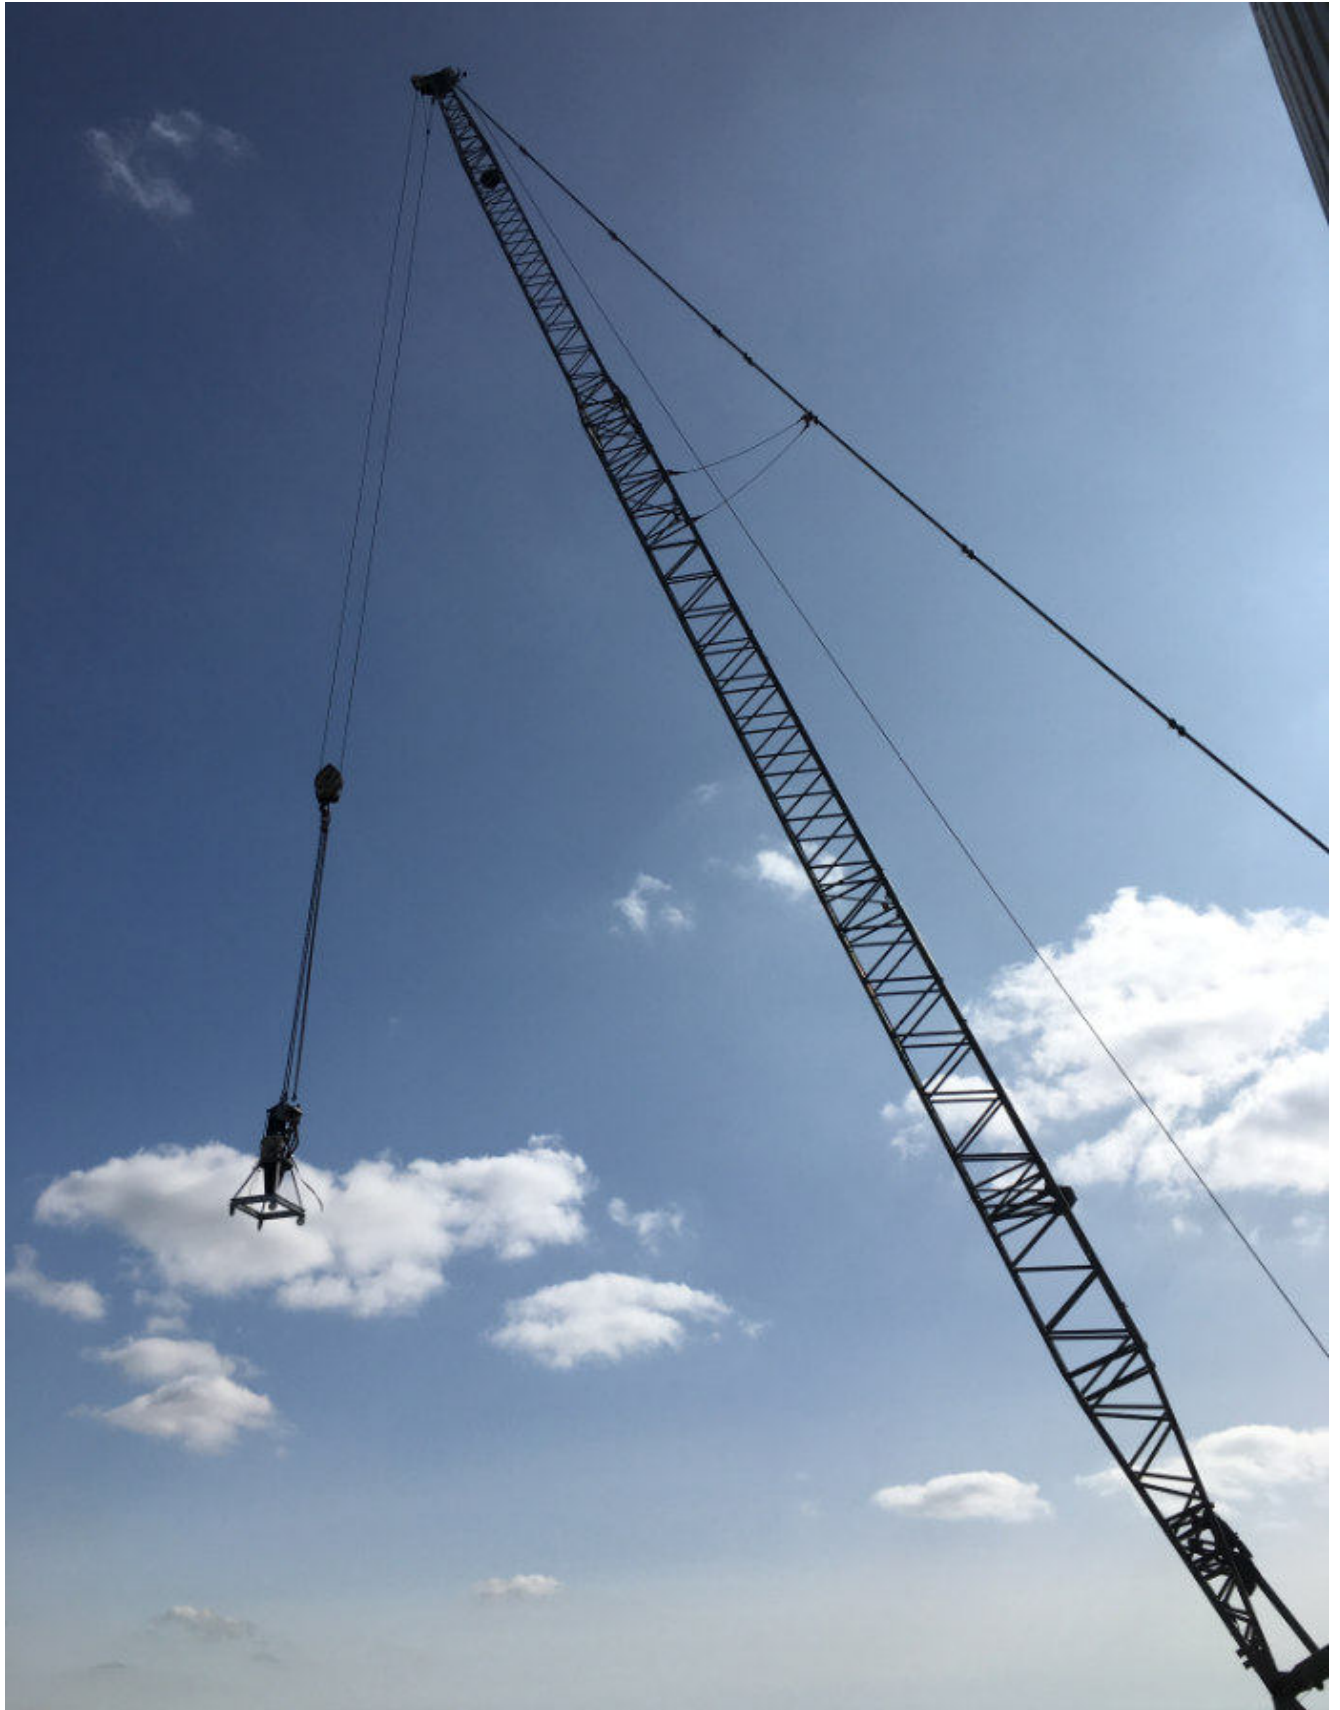
Below some pictures during transport up to the penthouse of line 4:

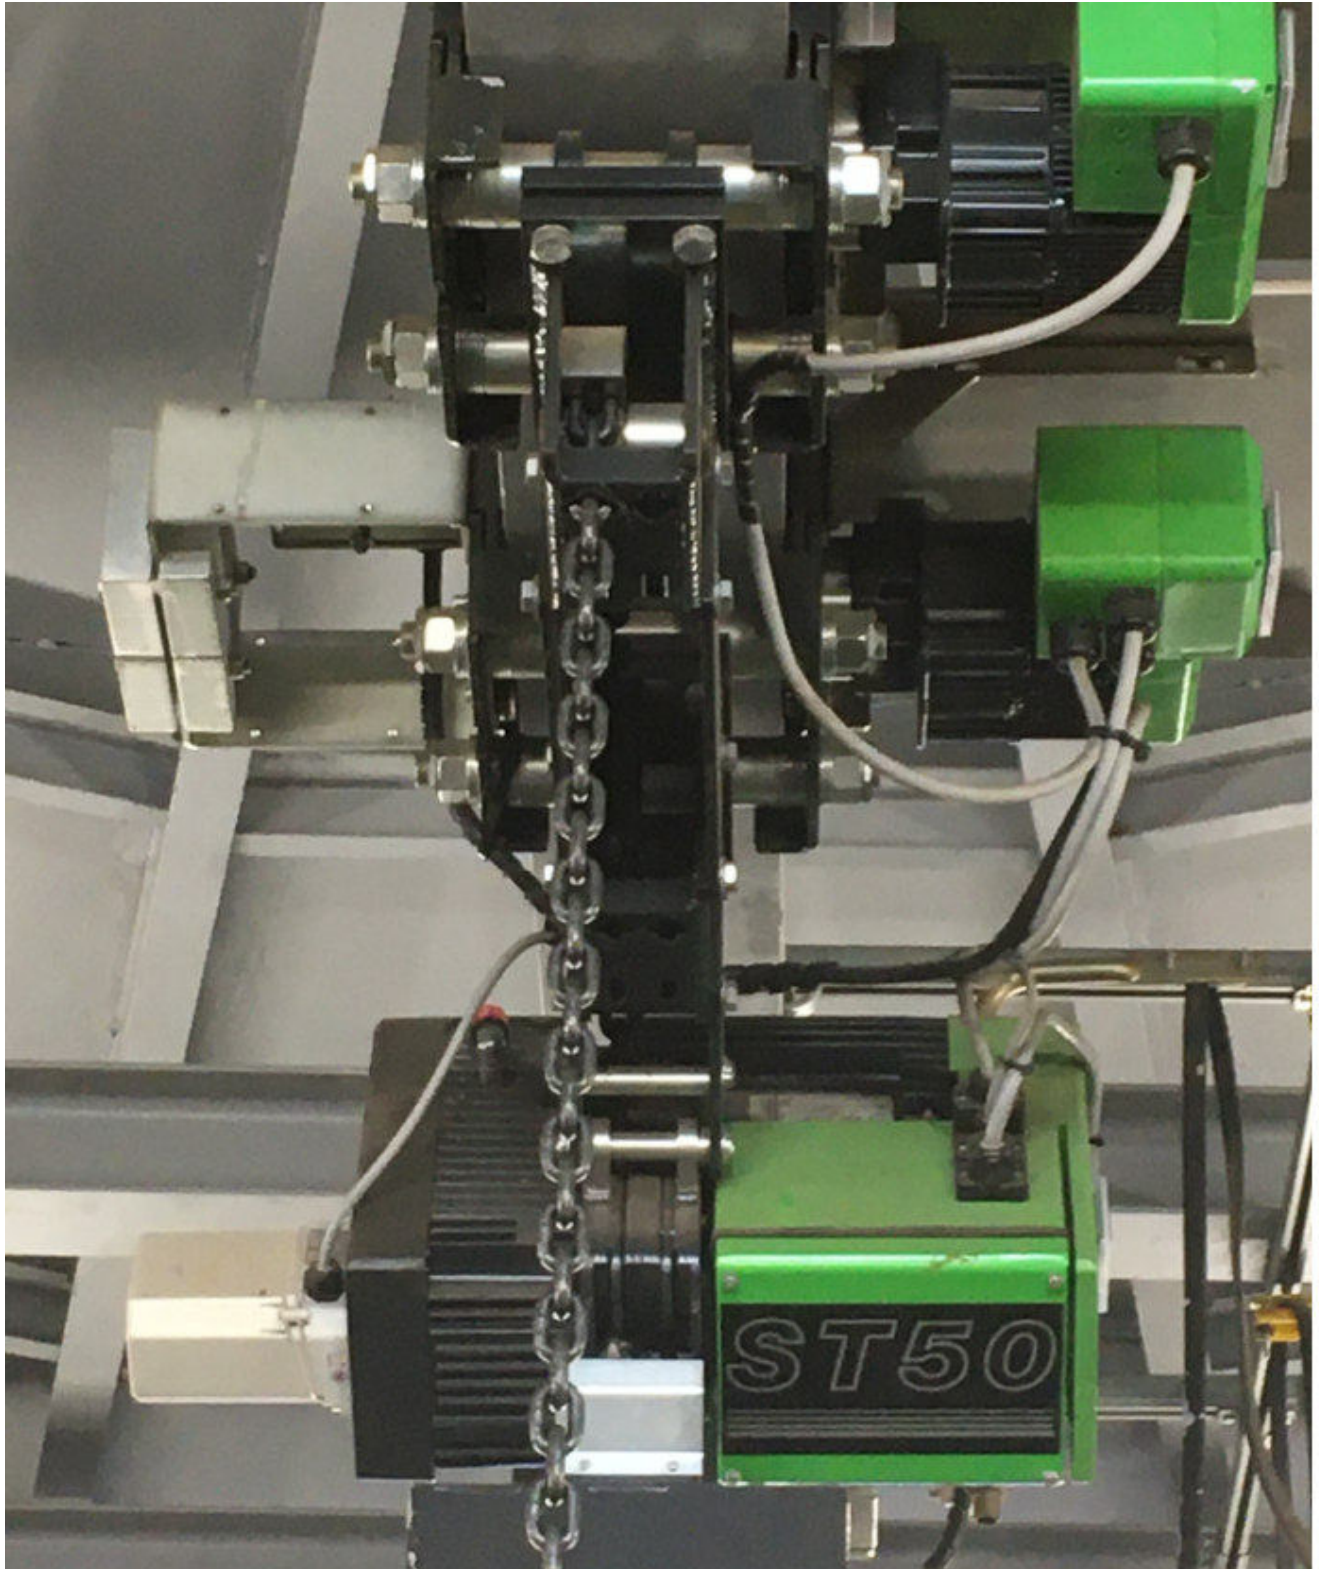
We saw at lifting of the atomizer that the lifting beam was vibrating very heavy and it was needed to stop several times till the beam was stopping vibrating.

On the picture we can see that the chain is not in the middle of the beam, this is mounted for a 2-chain system....It is easy to change this by changing the washers! In my opinion a must seen the very have vibrations of the lifting beam!!

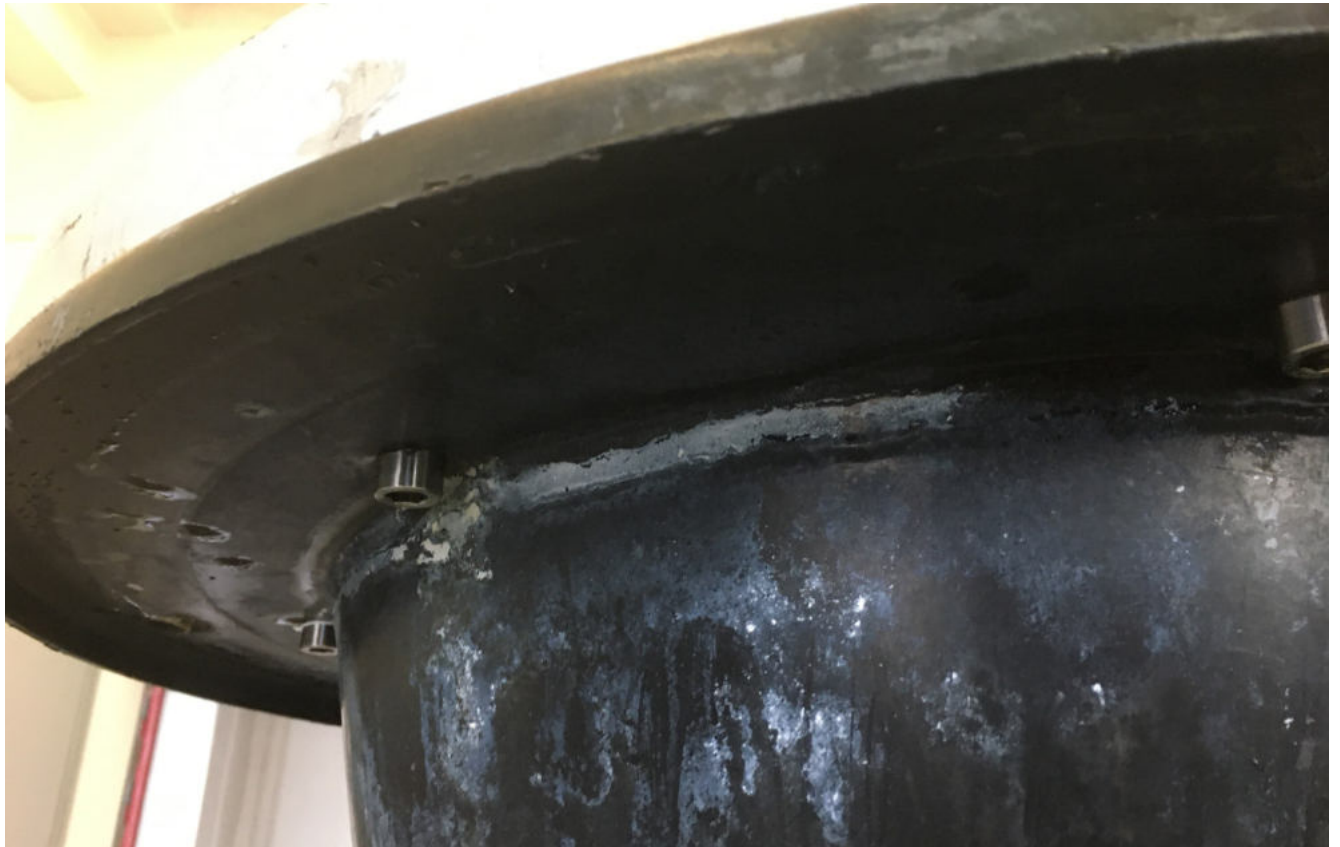
At this skirt the coating was in a good condition and nothing was loosen as seen at atomizer s/n 2241.

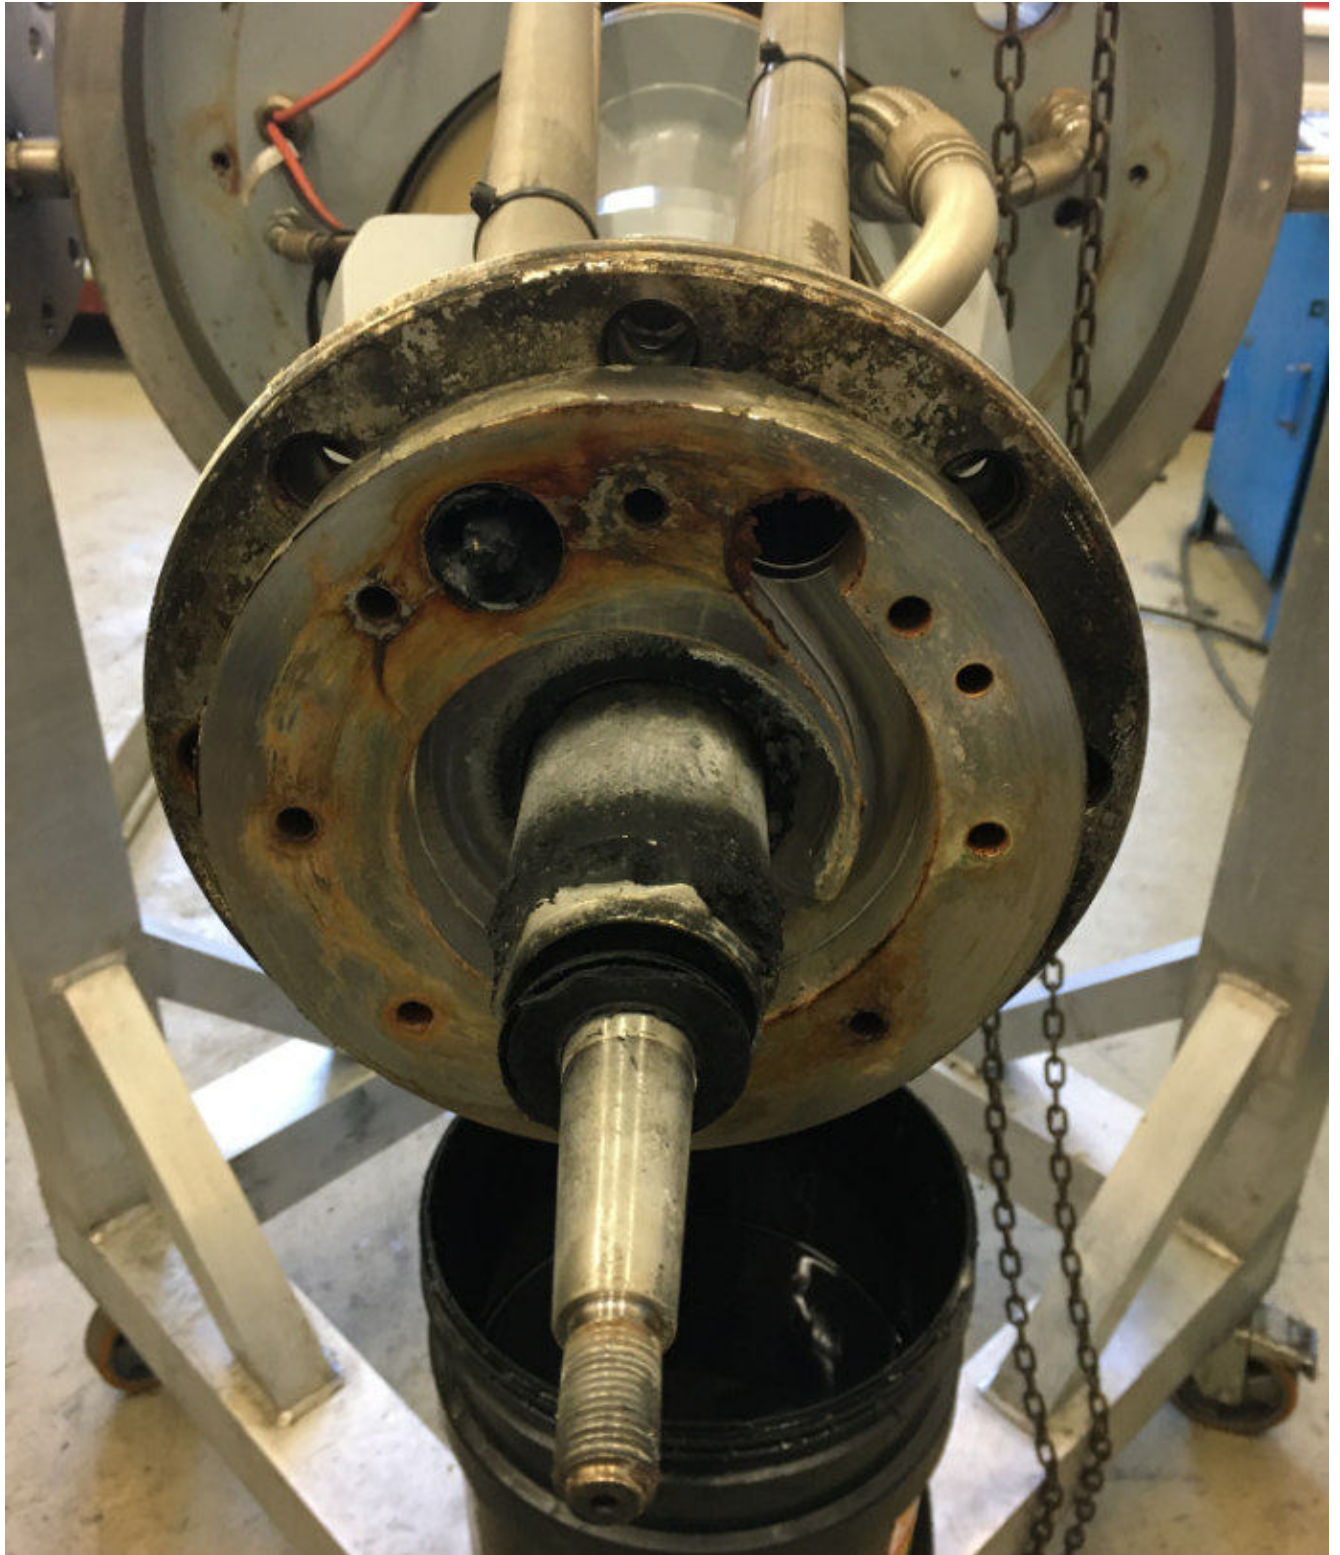
At this atomizer we saw that just the lower (outer) distributor was used as it should be and the upper (inner) distributor was complete clean, see picture below of the upper volute:

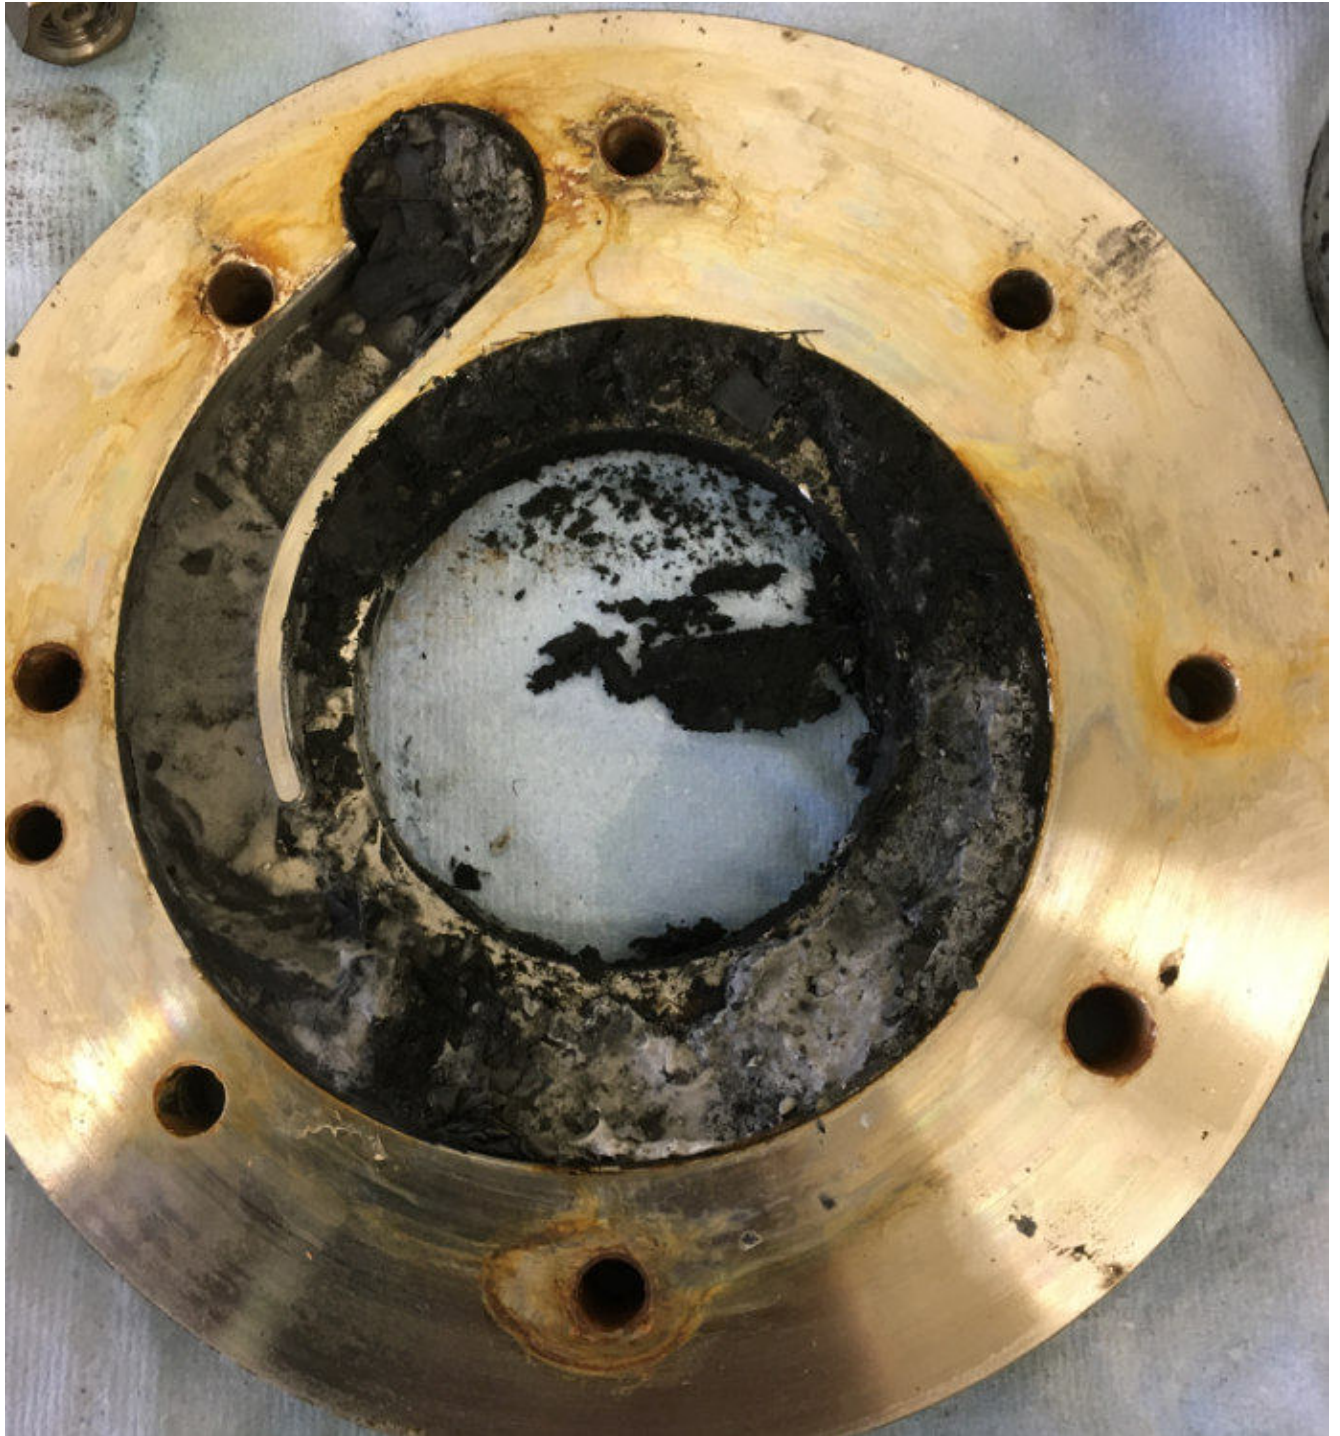
The next picture shows the lower (outer) distributor:

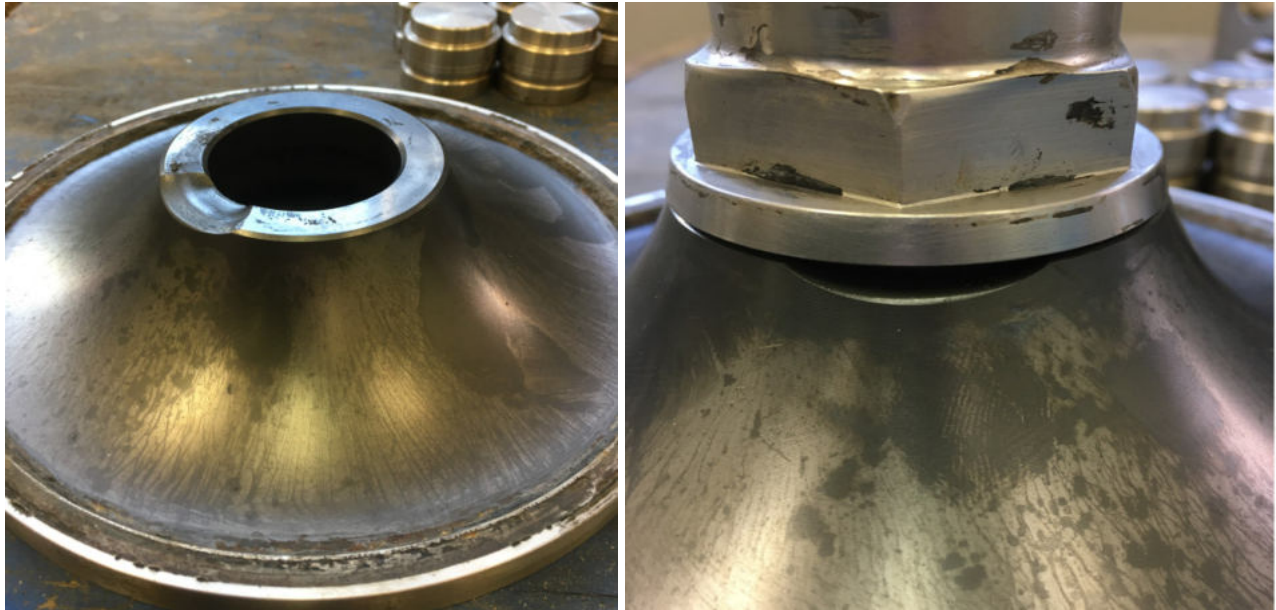
Only a small part of the lower wear plate was missing but as long the O-Ring is closing there is no problem to use it again, see pictures below:

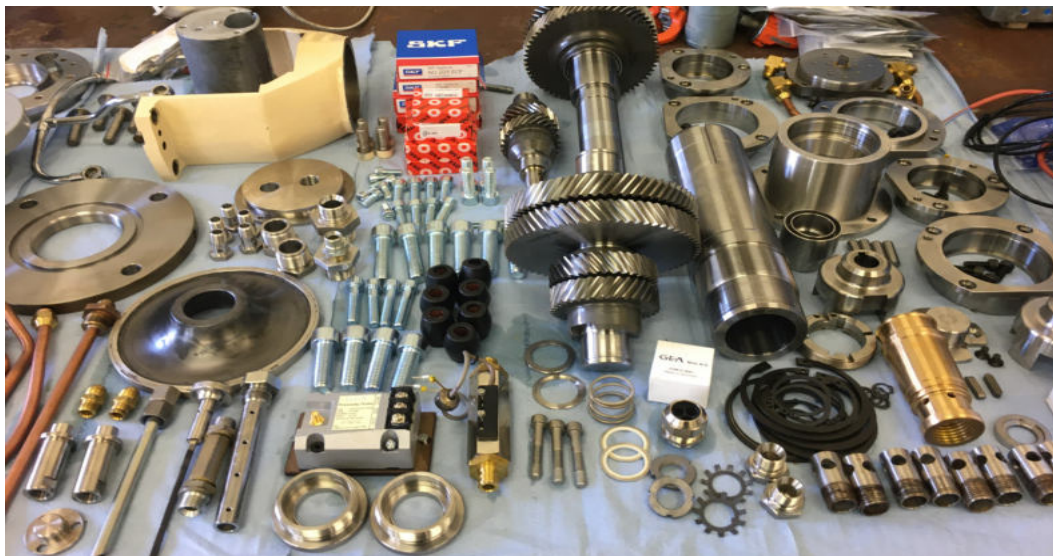
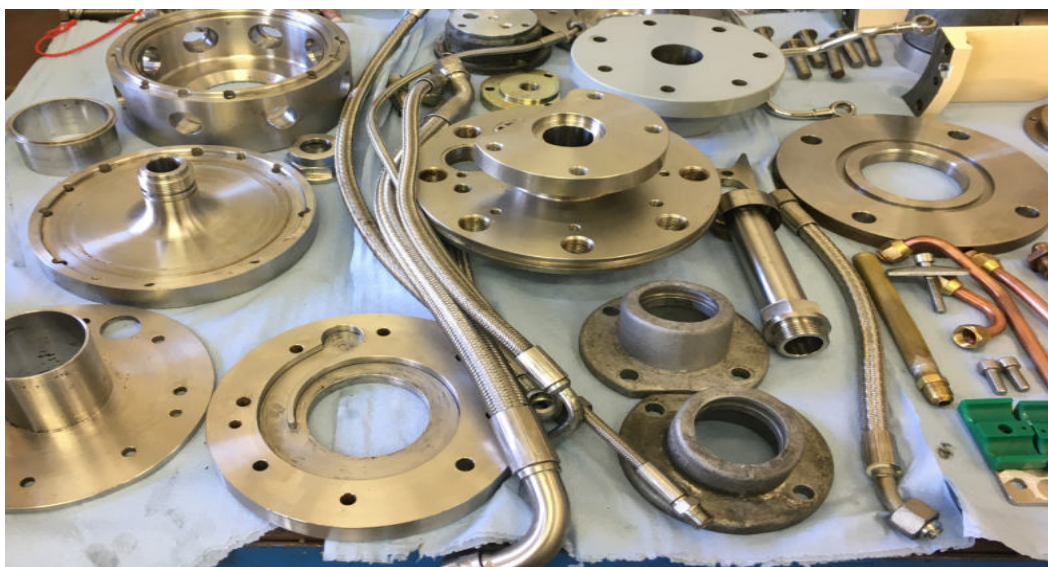
Below some pictures of most of the cleaned parts before assembling:

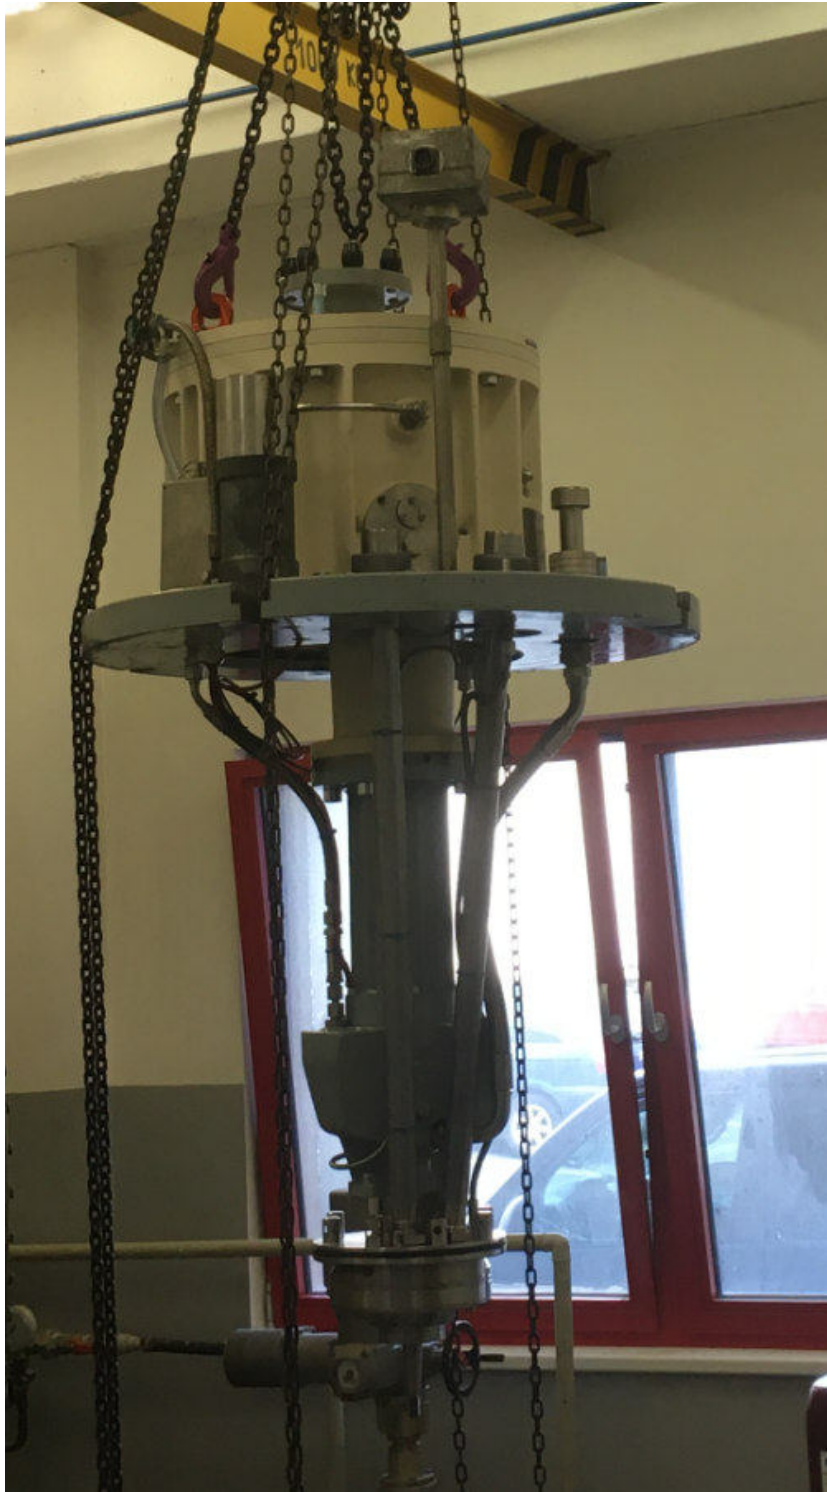
See below the lower part of the atomizer after assembling:

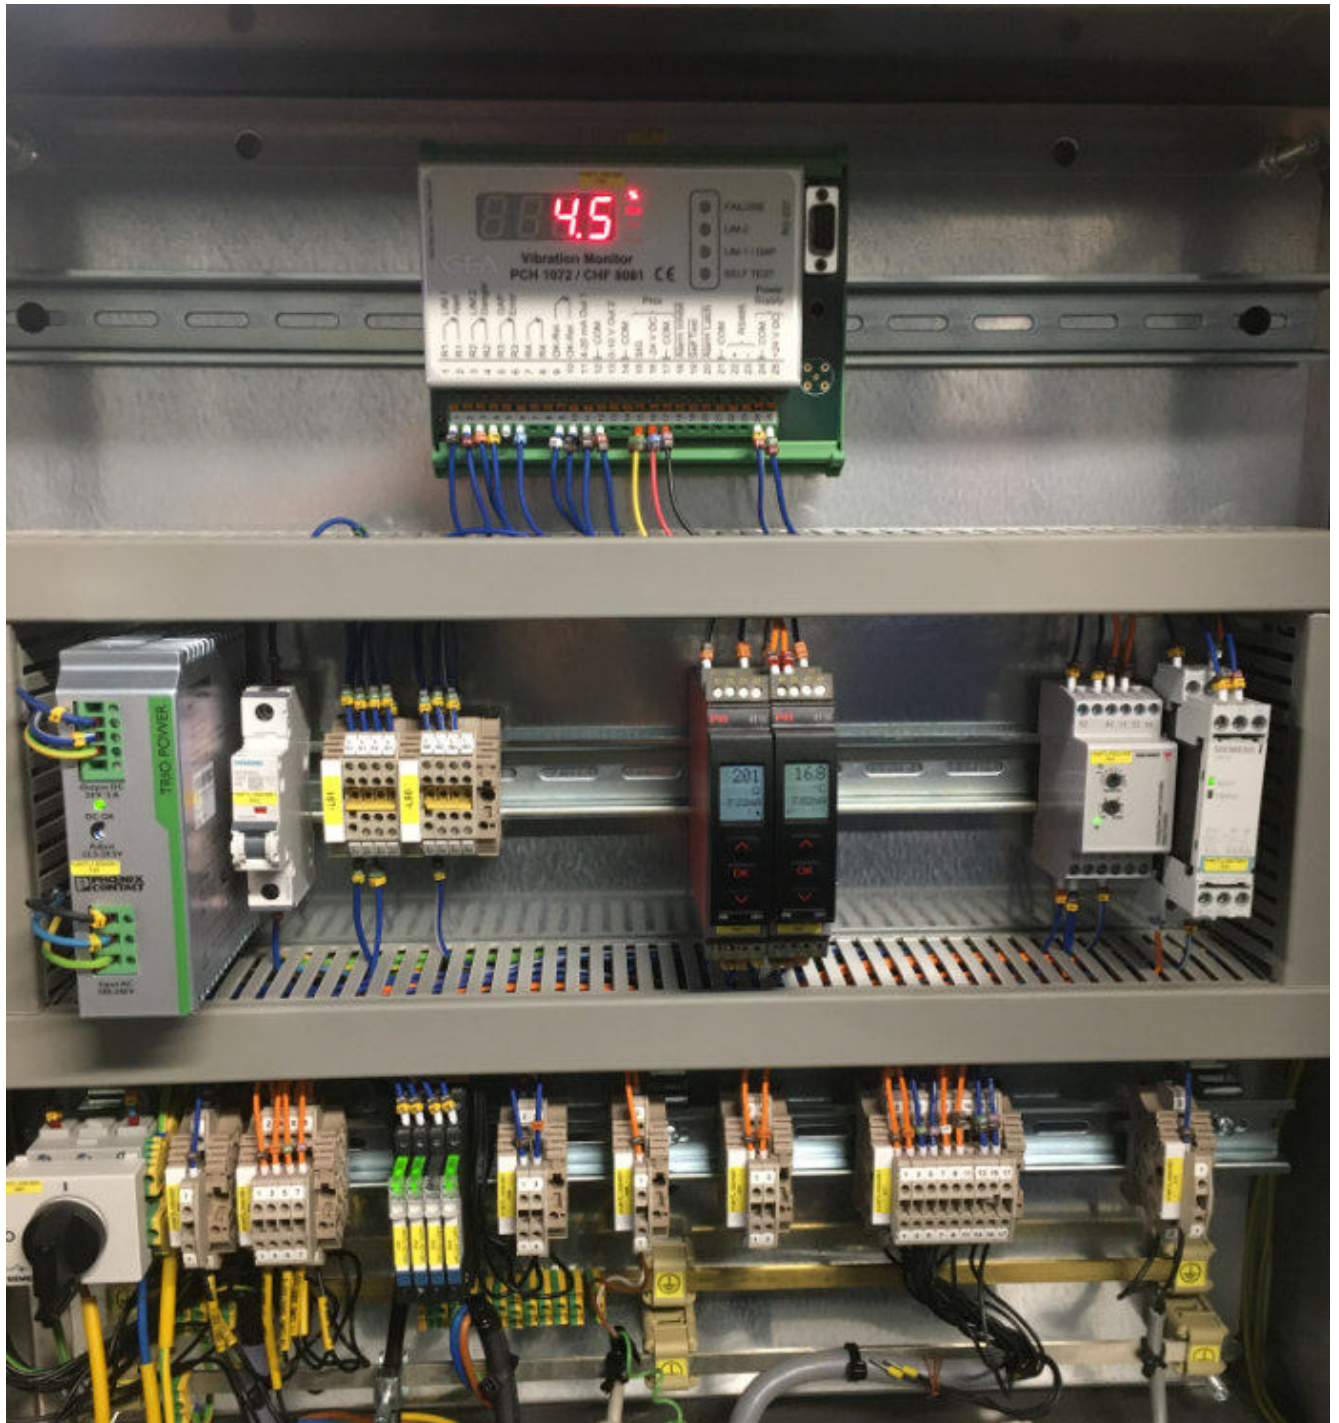
All signals were ok, see also a picture of the electrical box in the penthouse with a view on the vibrations and oil temperature:

This shows a vibration of 4,5% = 45 μ peak-peak in empty mode running. The oil temperature shows 16,8°C.

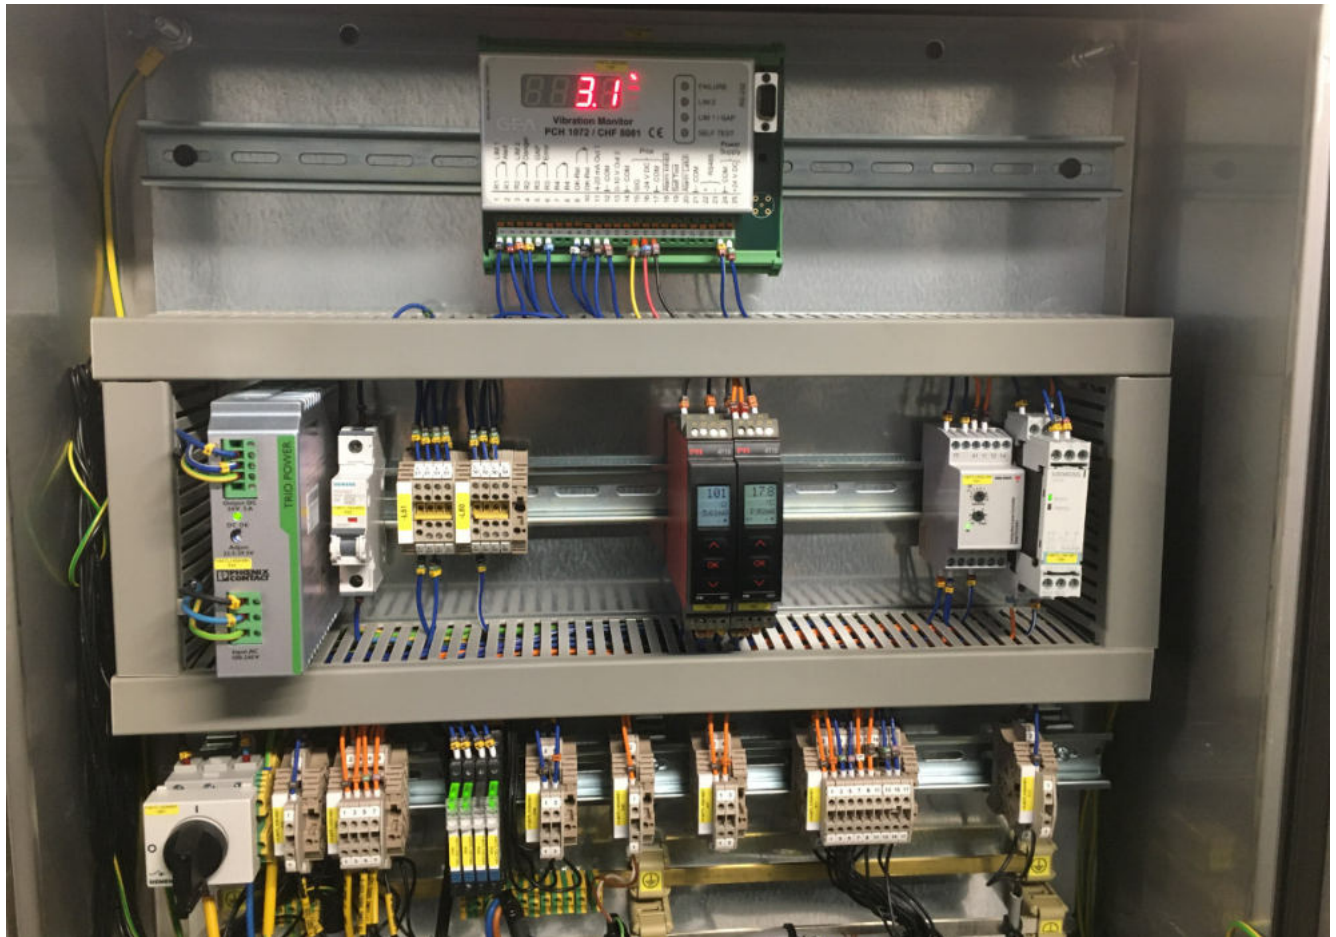
Atomizer s/n 2240 was tested as next, also first the test of the direction of the main motor and then starting up:

This shows a vibration of 3,1% = 31 μ peak-peak in empty running mode. The oil temperature shows 17,8°C.
